LETTER REPORT

21-080

Re: Elgin Street Flooding, Tara

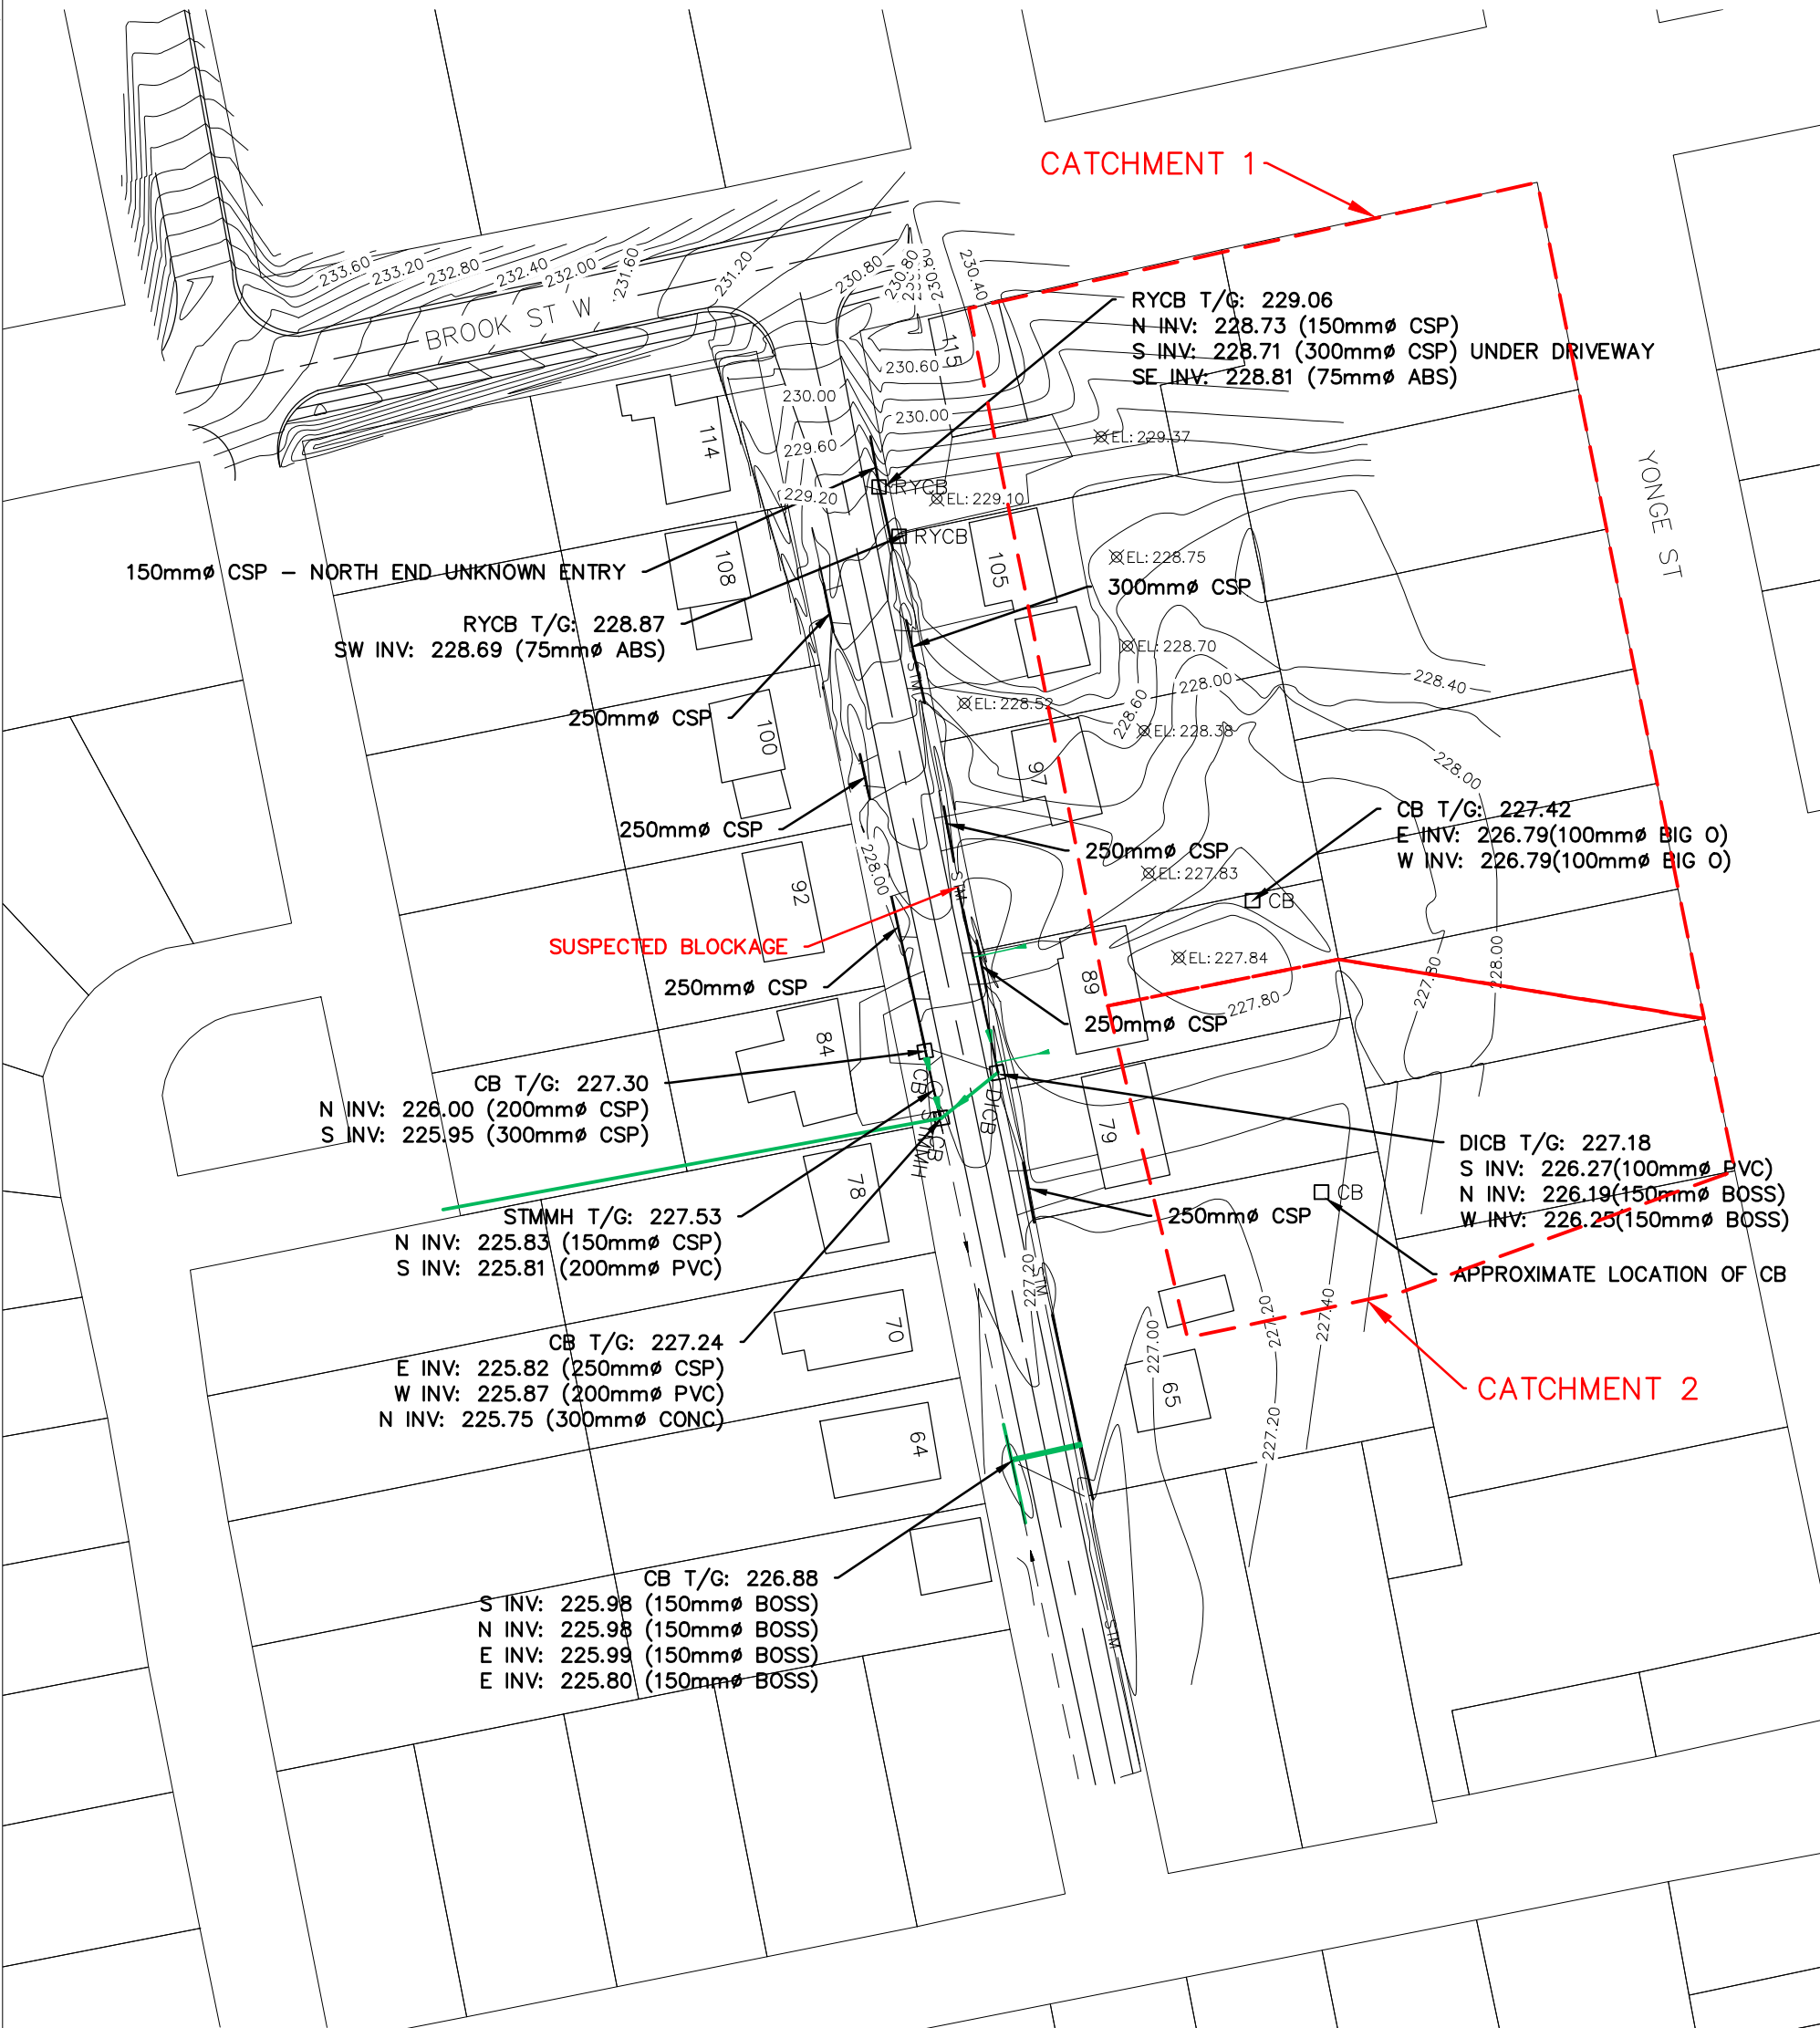
EXISTING DRAINAGE CONDITIONS
ELGIN AVENUE, TARA
MUNICIPALITY OF ARRAN ELDERSLIE

Lastly, a partial topographic survey of the site was completed to determine the area that is draining to the roadside ditch. Survey also focused on collecting information about existing catchbasin, driveway culverts, storm sewers, top of finished floor of the residences on east side of Elgin St. **Figure 1** indicates overall existing conditions.

The catchbasin in the backyard of 89 Elgin St. collects runoff from a very large area (0.93 ha) as indicated in **Figure 1**. Catchbasin has only 100 mm Big O outlet, which is undersized. 375 \varnothing pipe outlet at 0.75% slope is required as a minimum to handle a rainfall event of 110 mm/hour.

As noted earlier, 150 mm \varnothing storm sewer on east side of Elgin St. is collapsed and has blocked the water flow. It is likely that any foundation drains connected to this sewer north of the blockage location, were unable to properly drain water, leading to backup in the basements and/or footings, and possibly rising through granular backfill around basement walls.
