Wind Turbine Failures

Attachment 1: Bow Lake, Algoma Region, Ontario

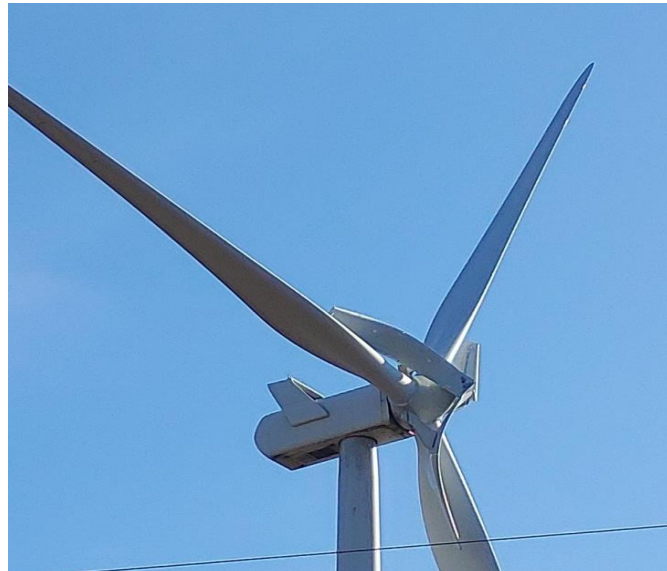
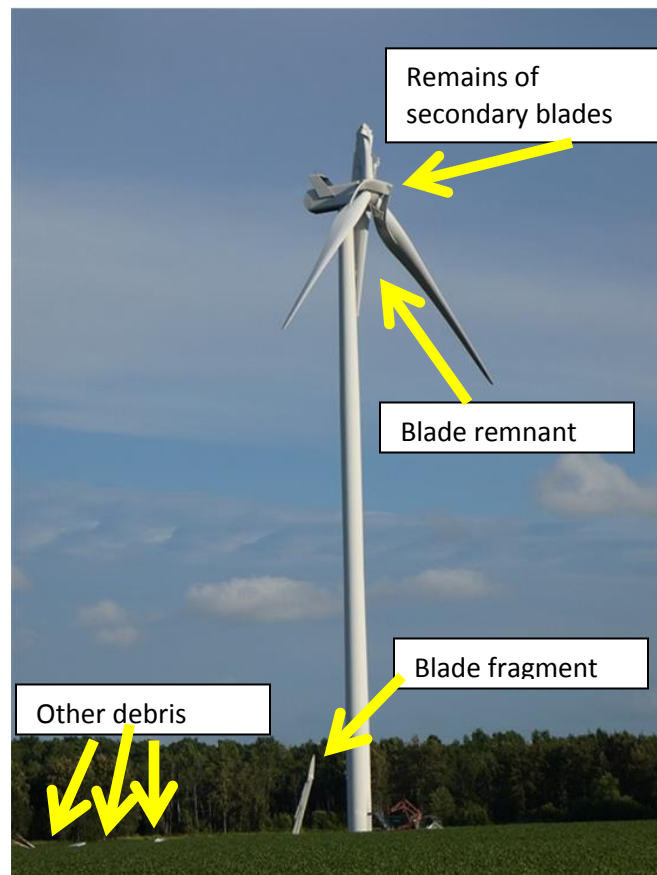
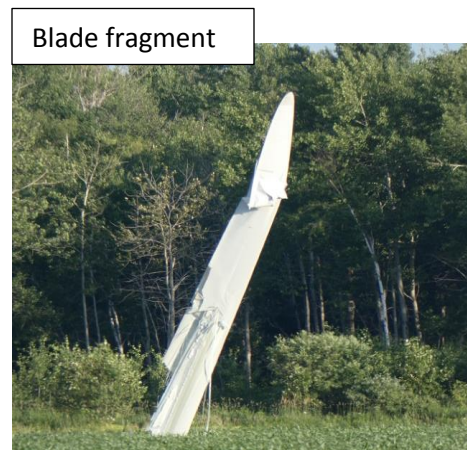
Attachment 2: Skyway 8, Grey County, Ontario

This turbine was retrofitted approximately 3 months prior to the failure with a secondary rotor of three curved blades that fastened to the hub between the existing blades. This experimental device was not part of the original design and was added to increase power output. The failure resulted in the separation of one of the secondary blades and one of the existing blades. Although the exact sequence of the failure is not known, the most likely scenario is that the experimental blade partly separated, impacting the main blade which then failed.

MECP approved the change but there is no public information confirming that the turbine could handle the additional static and dynamic loads imposed by the secondary rotor.

This turbine was located only 195m from the road, Grey Rd. 8. The road closure that was immediately put in place for public safety confirms that existing setback requirements are insufficient. The failure raises many questions concerning how this project was executed and the engineering safety margins for the original wind turbine design.

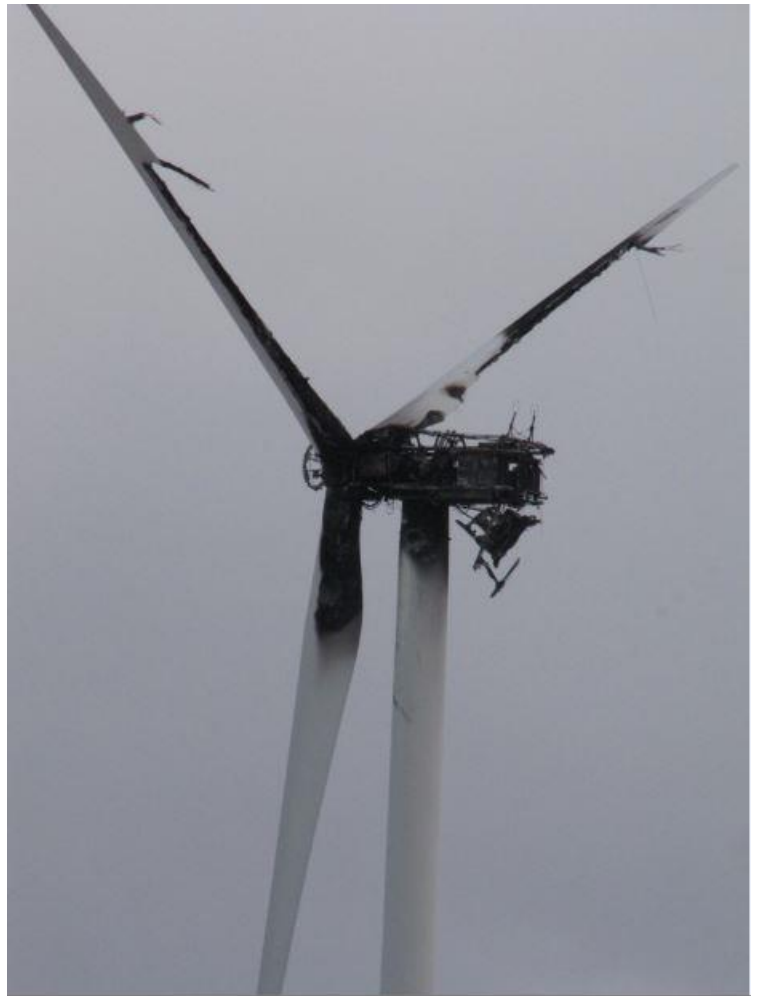
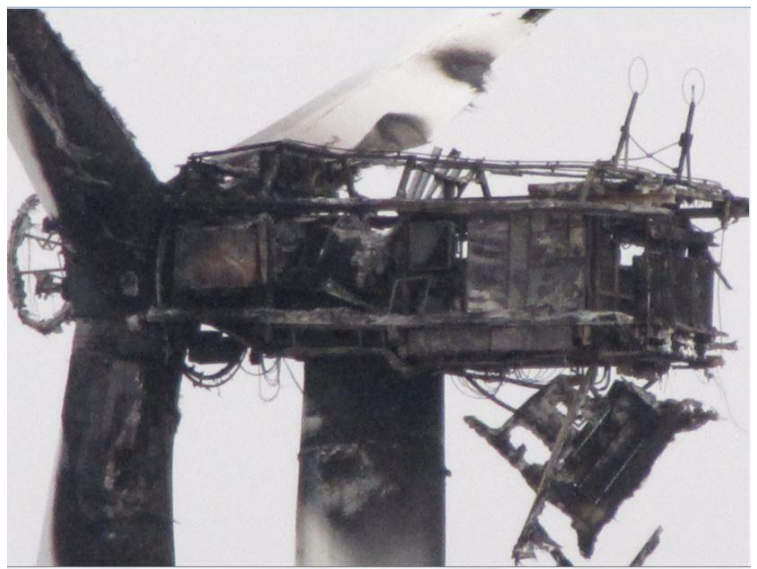
Attachment 5: Kingsbridge 1, Ashfield-Colborne-Wawanosh

The fire started at about 1 am and burned for about two hours. Most of the nacelle was completely destroyed. The intensity of the fire also ignited the blades.

The fire department was called to the site but there was not much that they could do given the elevation of the fire and risks posed by burning pieces of the nacelle and the blades that were falling off of the towers.

Blades continued to rotate and could not be stopped due to the fire in control mechanisms.

A representative of the operator addressed ACW Council the following day and indicated that elements of the turbine were found over 200 metres from the tower.

This failure highlights the need for fire identification and suppression systems to be installed within the nacelles of all wind turbines.

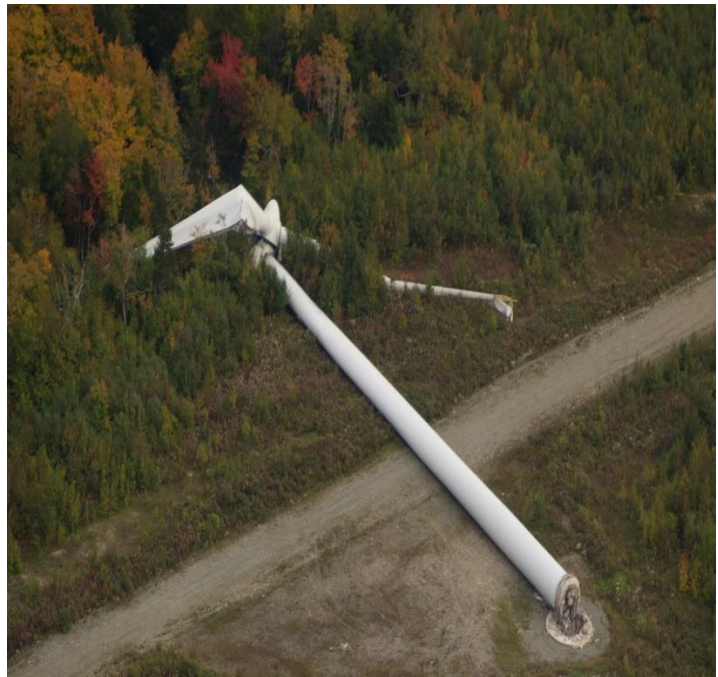
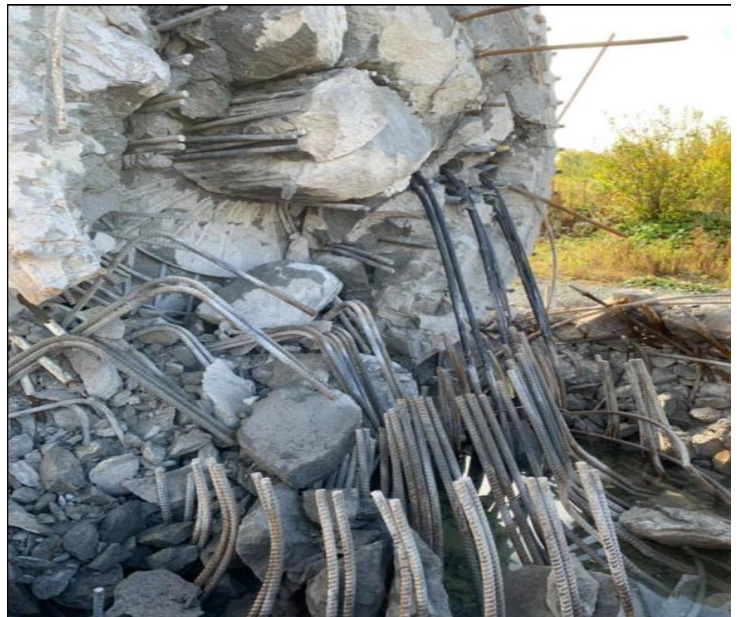
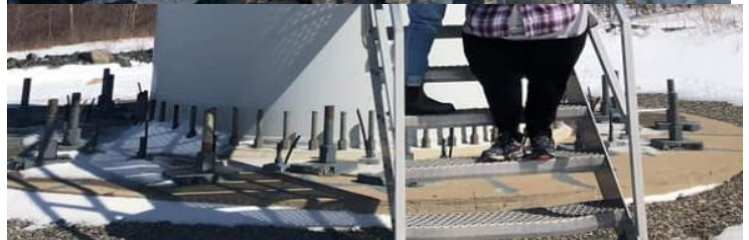
Attachment 7: Kent Hills, New Brunswick

As confirmed by the operator, this tower collapse was linked to a foundation failure (sub-surface crack propagation). The tower itself seems to have all the sections intact and bolted together. Basically, the pictures indicate that the top part of the foundation directly below the tower base was no longer adequately supporting the tower.

A close-up picture of the foundation shows the failed surfaces consists of concrete rubble and rebar. There does not seem to be evidence of the long primary anchor bolts that should fasten to the flange at the base of the tower and then be embedded deep into the concrete foundation.

Earlier pictures taken of wind turbines in this project indicate that numerous anchor bolts had been installed in the concrete bases. This is highly unusual and suggests that they were added when problems with the foundations became evident.

The foundation problem(s) that caused the failure are very likely not an isolated case. Foundation failures can result from many factors i.e., faulty design, quality control, construction techniques, procedures etc.
