## Summary Report:

Structure Name: Ross St. Bridge

Road Name: Ross Street

Inspection Date: 2020-09-18

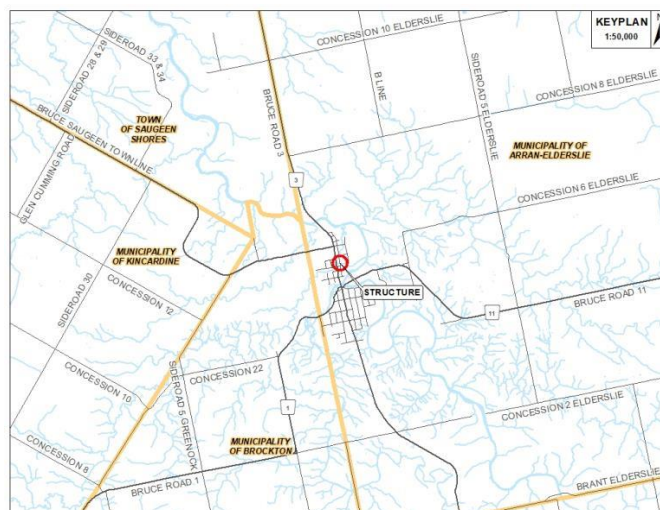
Looking North

Overall Comments: Box beam of girders in fair condition. Recommend patch repairing abutment walls, barriers and deck. Waterproof and pave deck.

Element:	Work Required	Period	Cost
Abutments	Patch repair abutment walls	1 to 5 yrs.	\$1,500
Decks	Patch repair	1 to 5 yrs.	\$27,500
Decks	Waterproof and pave	1 to 5 yrs.	\$28,000
Sidewalks/curbs	Patch repair	1 to 5 yrs.	\$1,000
			\$0
			\$0
			\$0
Various	Associated Work		\$44,500
		<b>Total</b>	<b>\$102,500</b>
