**MULTI-MUNICIPAL ENERGY WORKING GROUP**  
TOM ALLWOOD, COUNCILLOR, GREY HIGHLANDS, CHAIR  
JIM HANNA, DEPUTY MAYOR, HURON-KINLOSS, VICE-CHAIR  
1925 BRUCE ROAD 10, BOX 70, CHESLEY, ON NOG 1L0  
[519-363-3039](tel:519-363-3039) FAX: [519-363-2203](tel:519-363-2203)  
[jhamilton@arran-elderslie.ca](mailto:jhamilton@arran-elderslie.ca)

**RE: February 9 Engagement Session with the Ministries of Natural Resource and Environment**

## Wind Turbine Failures

## Attachment 1: Bow Lake, Algoma Region, Ontario

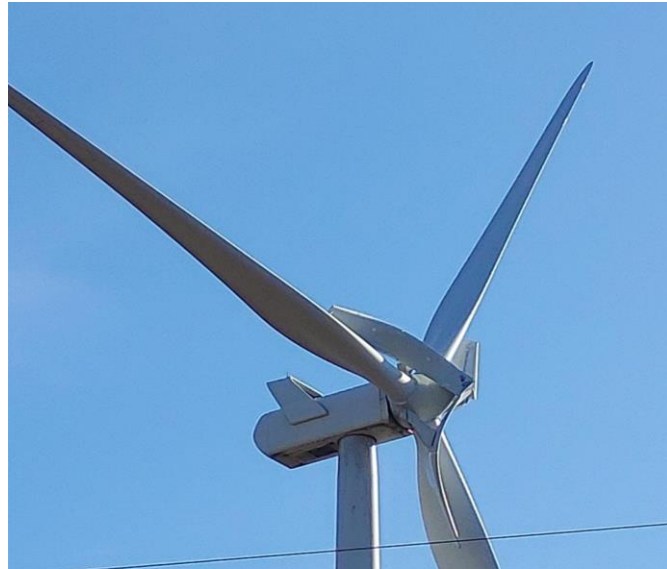
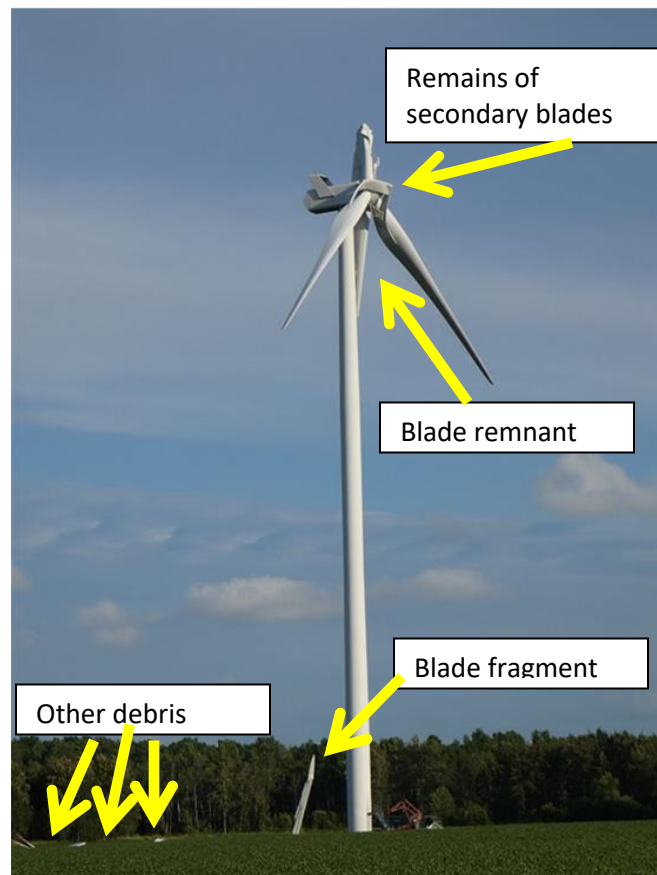
This turbine was retrofitted approximately 3 months prior to the failure with a secondary rotor of three curved blades that fastened to the hub between the existing blades. This experimental device was not part of the original design and was added to increase power output. The failure resulted in the separation of one of the secondary blades and one of the existing blades. Although the exact sequence of the failure is not known, the most likely scenario is that the experimental blade partly separated, impacting the main blade which then failed.

MECP approved the change but there is no public information confirming that the turbine could handle the additional static and dynamic loads imposed by the secondary rotor.

This turbine was located only 195m from the road, Grey Rd. 8. The road closure that was immediately put in place for public safety confirms that existing setback requirements are insufficient. The failure raises many questions concerning how this project was executed and the engineering safety margins for the original wind turbine design.
