Re: Priebe Bridge, Structure E1 on Sideroad 25

Summary Report:

Ontario Structure Inspection Manual - Inspection Report:

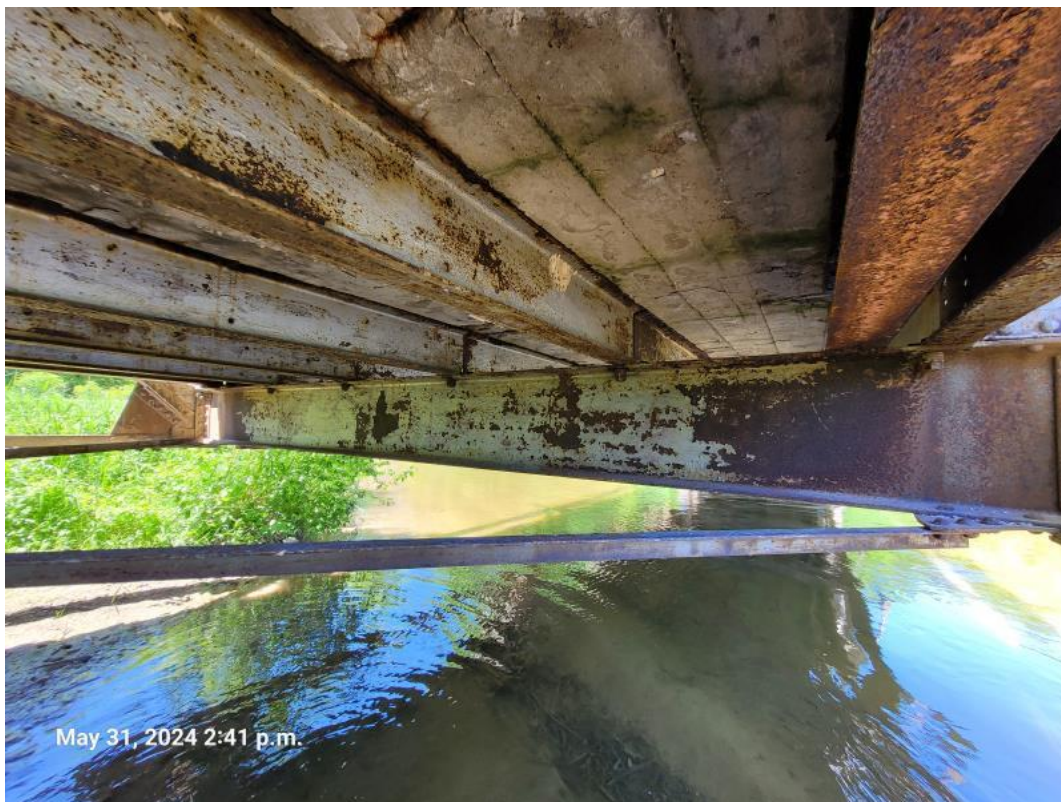
With regards to the concrete deck, there is one hole in the deck at the north end that has been covered with a steel plate and a second hole has started in the south end of the deck. The concrete is about 125mm thick, but concrete has spalled off the underside of the deck; about over 40% of the soffit, leaving the reinforcing steel exposed in those areas. When the concrete deck is exposed to heavier vehicle loads, we suspect the deck flexes and more concrete will fall off; as such, the deck becomes weaker. Additionally, exposed reinforcing steel corrodes more quickly than steel electrochemically protected by the concrete, leading to steel section loss. Therefore, the bridge deck should be replaced.

3-Soffit

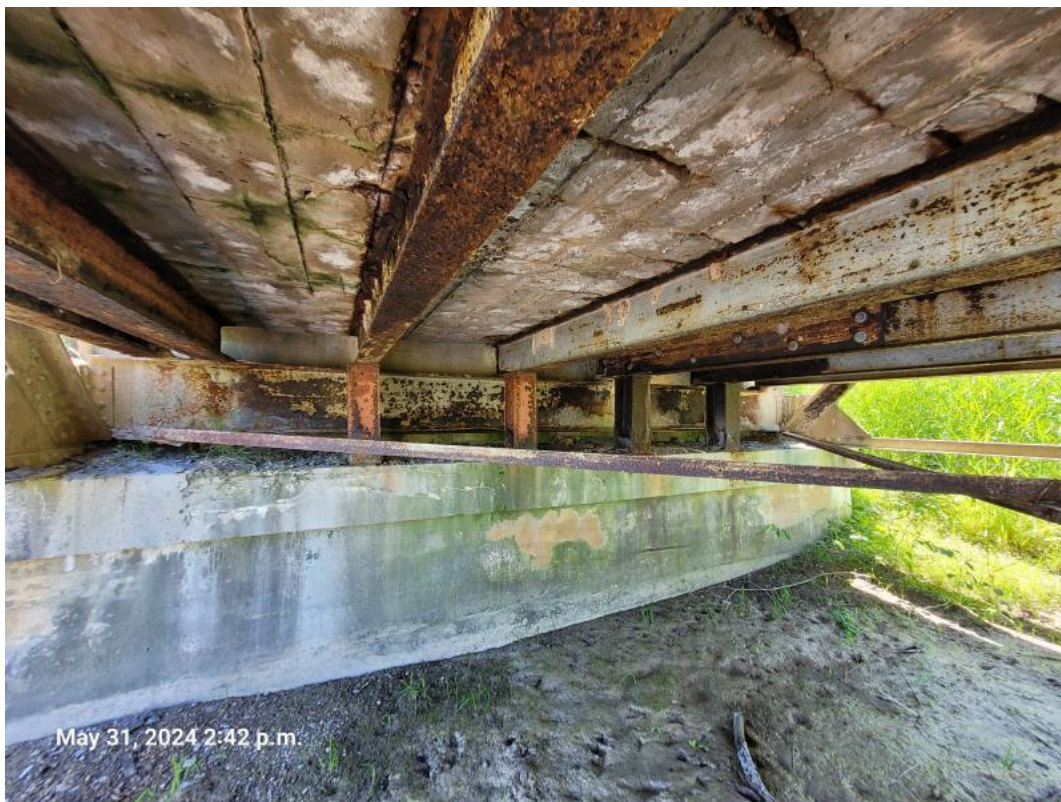
4-Soffit and South Abutment

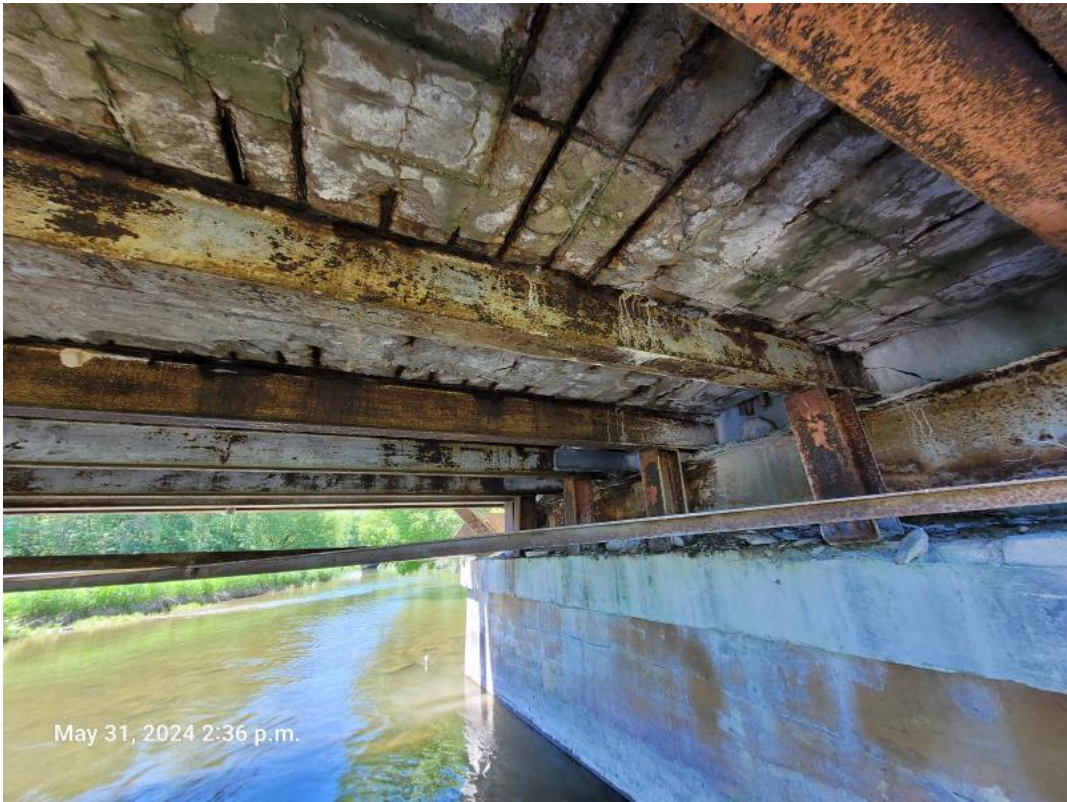
With regards to the stringers (floor beams) under the deck, there were originally 6 stringers under the concrete deck in each bay, but in 2002, supplemental stringers were installed along the outside edge of the bridge deck. When reviewing the north span, 4 of the original stringers did not appear to be providing support for the deck, as large portions of their top flanges have corroded all the way through. As a result, loads must be transferred through the weak

5-Soffit and Stringers at North End (1)

Within the other three spans along the length of the bridge, there is at least one stringer, with a portion of the top flange rusted through, which is providing limited support to the underside of the deck. Additionally, all five other stringers are generally corroding with localized pitting along the top flanges, which has led to the weakening of these stringers. When doing repairs, we recommend replacing all the stringers in the bridge deck.

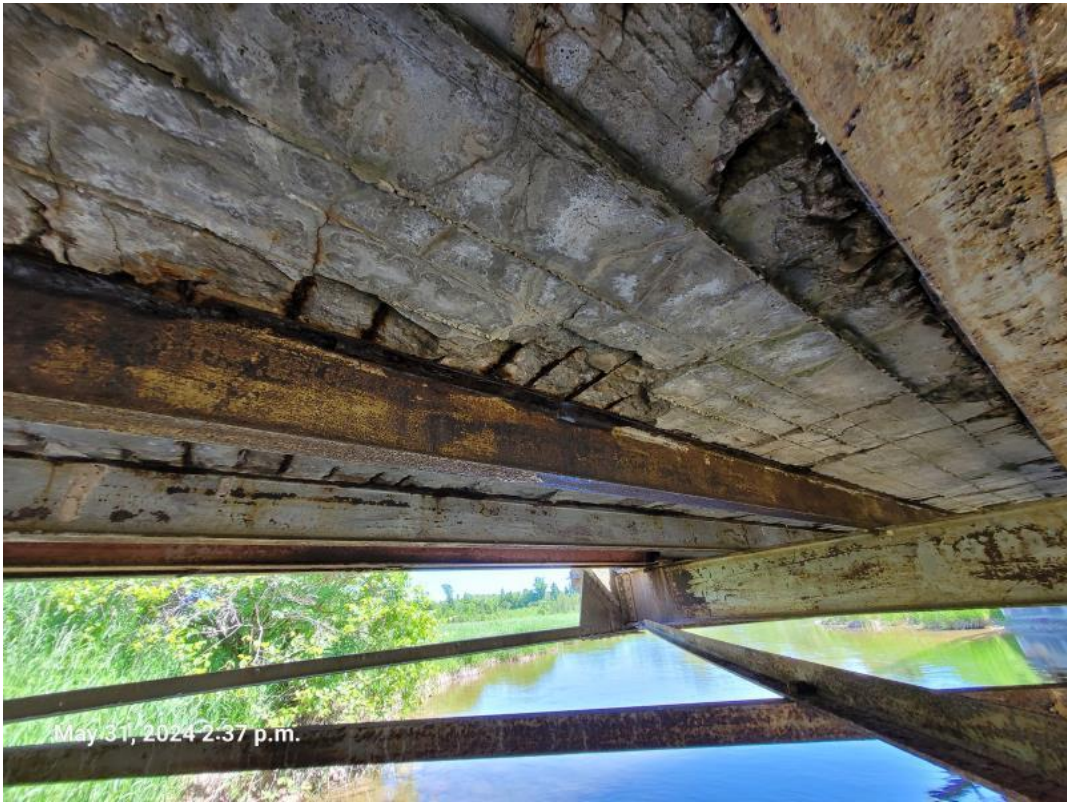
6-Soffit and Stringers at North End (2)

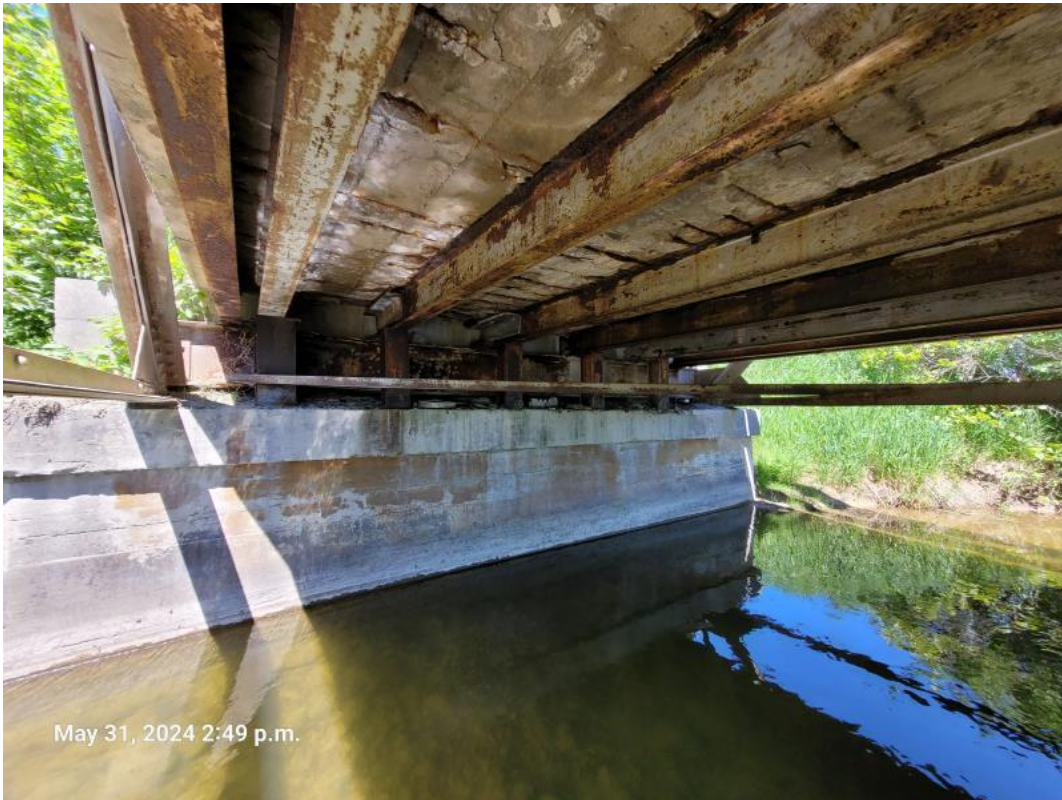
7-North Abutment

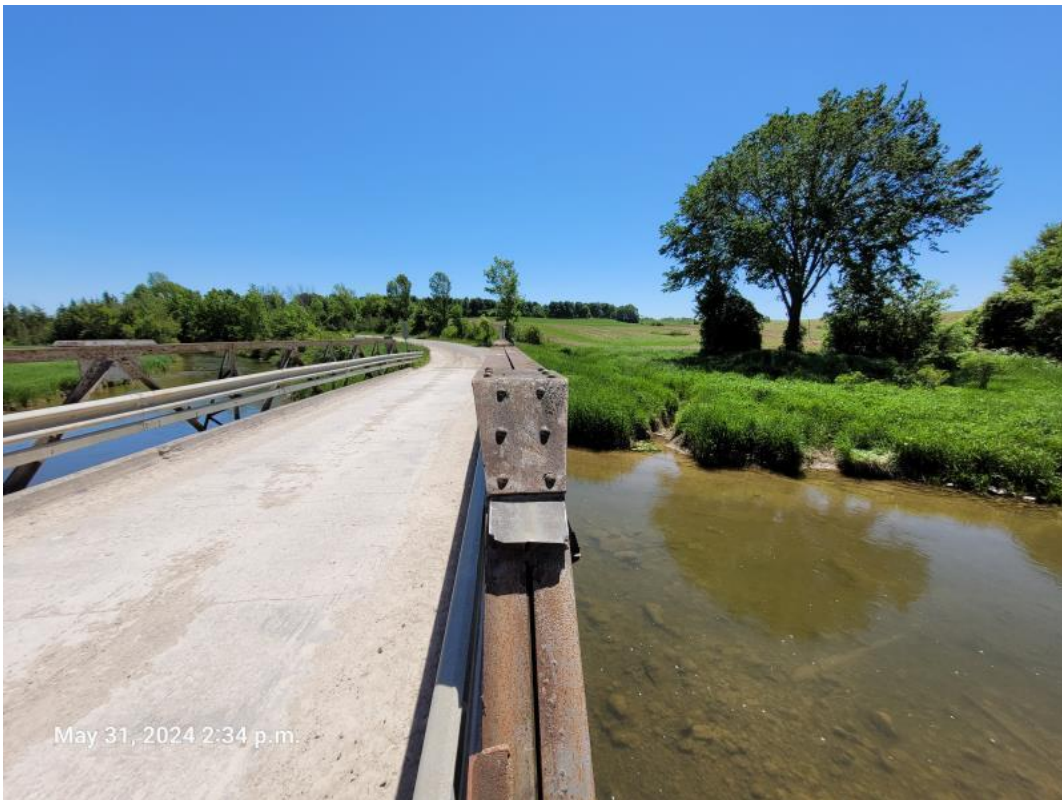
8-West Girder Slight Deflection

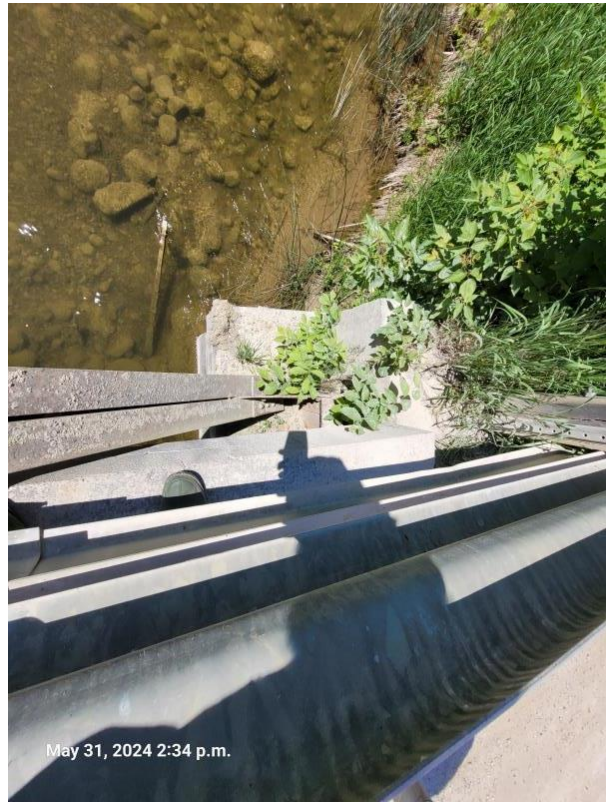
9-West Girder Bearing Point

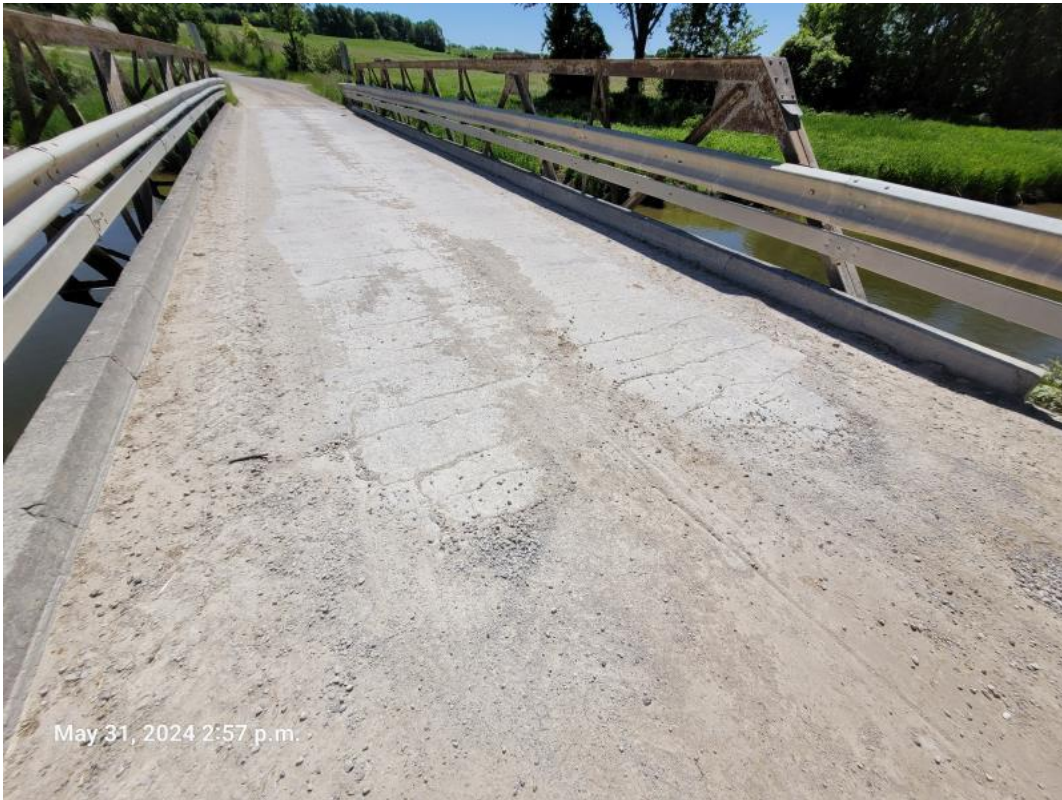
Deck Top Cracks

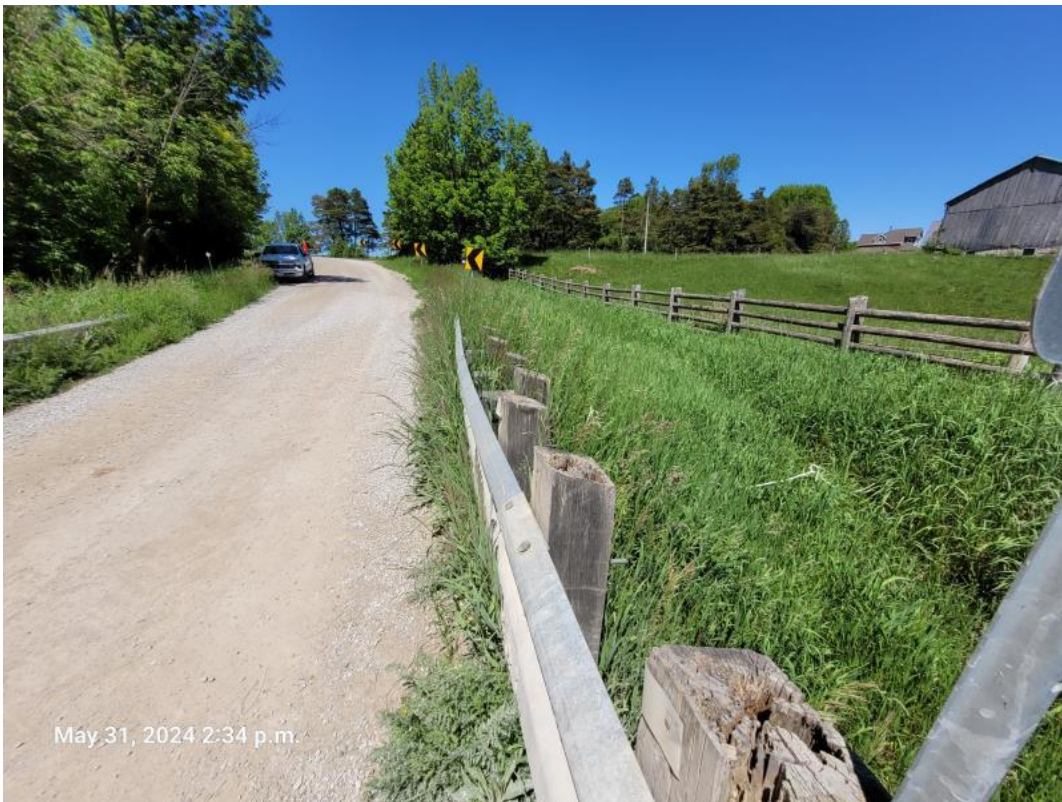
95% (47.69)	5% (2.51)	\$10,040	\$3,815
Comments:	Section of guide rail on south approach is badly damaged and should be replaced.					
Performance Deficiencies:						
Recommended Work:	Replace damaged section of guiderail			Recommended Timing:	< 1 year	
Maintenance needs:						
Maintenance work:				Maintenance Priority:

Guiderail Posts

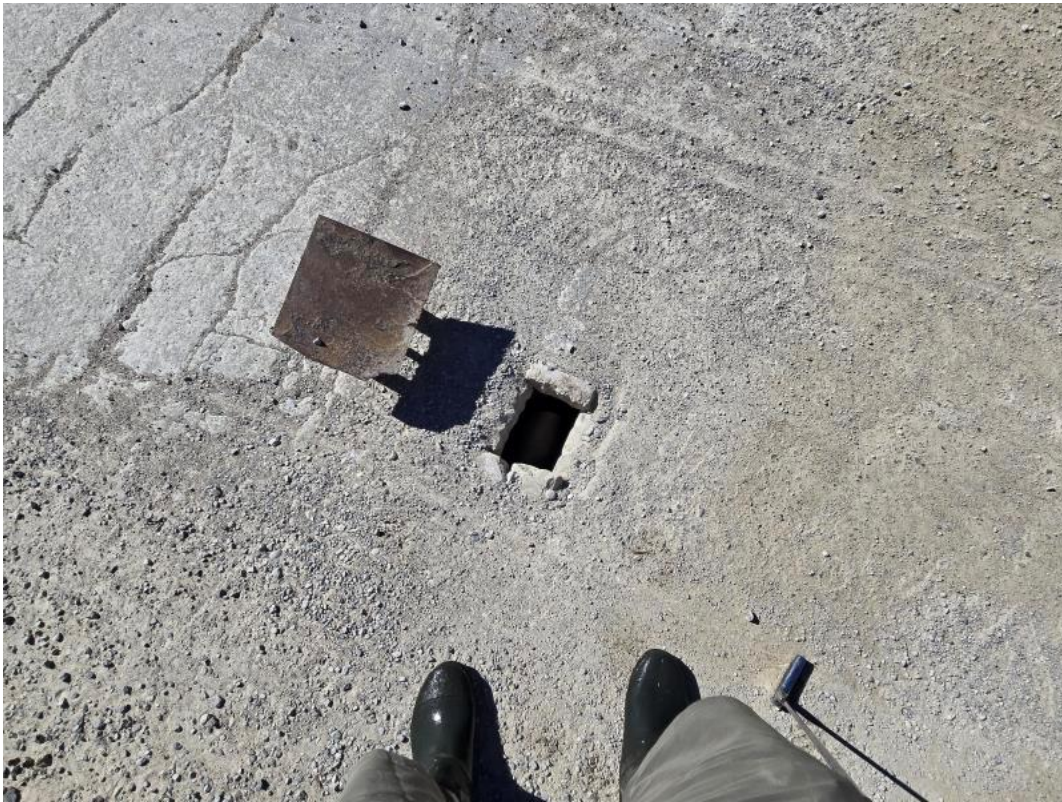
Hole In Bridge Deck and Temporarily Installed Steel Cover Plate

To avoid closing the bridge and maintaining the 5 tonne load limit, supplemental stringers could be installed under the north and south bays of the bridge and localized repairs should be completed to the bridge deck where the holes are present, or have started to form. These repairs should be completed as soon as possible, and we would recommend the Township budget \$27,000 for construction and \$6,000 for Engineering to complete these repairs. Our concern is that although these repairs should provide adequate support for the bridge deck, given the deck is in poor condition and there is a risk that a heavier vehicle will break through the deck, we are recommending that the load limit be kept at 5 tonne until the bridge deck is replaced. At the 5 tonne load posting, the bridge is insufficient to support the Township's grader or other snow plows. Also, these repairs are only considered a short-term solution because it does not address the fact that most of the concrete deck will still be in poor condition.

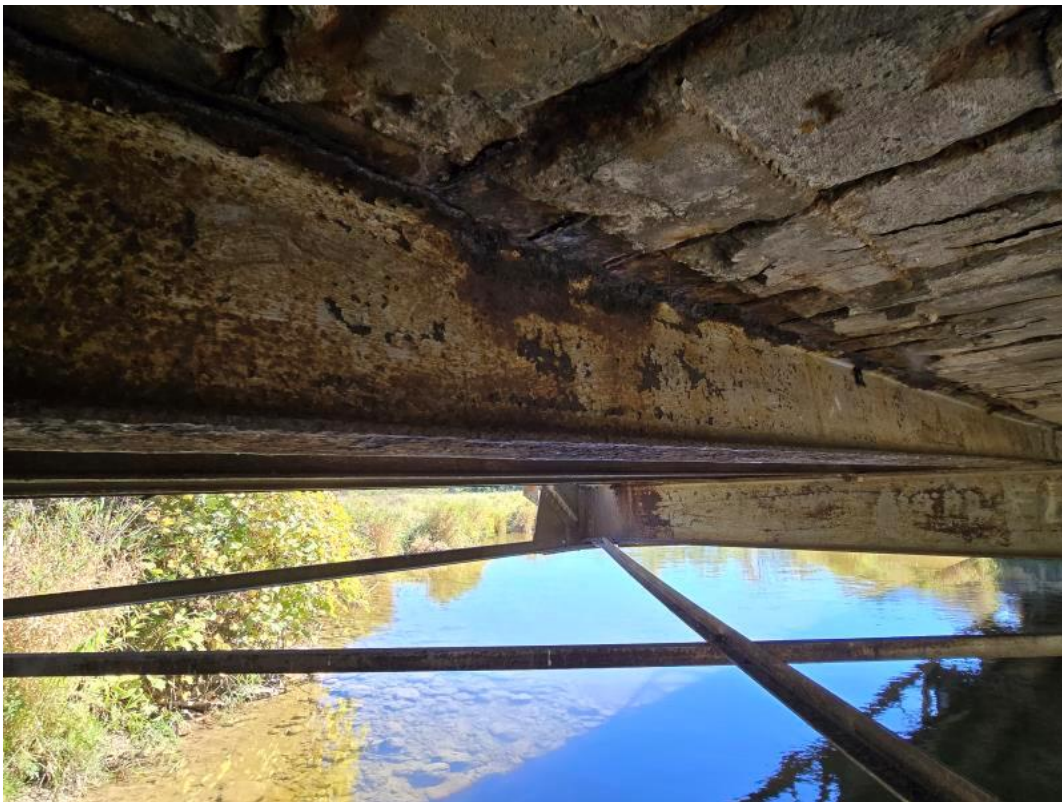
North Bay Stringer Corroded Top Flange

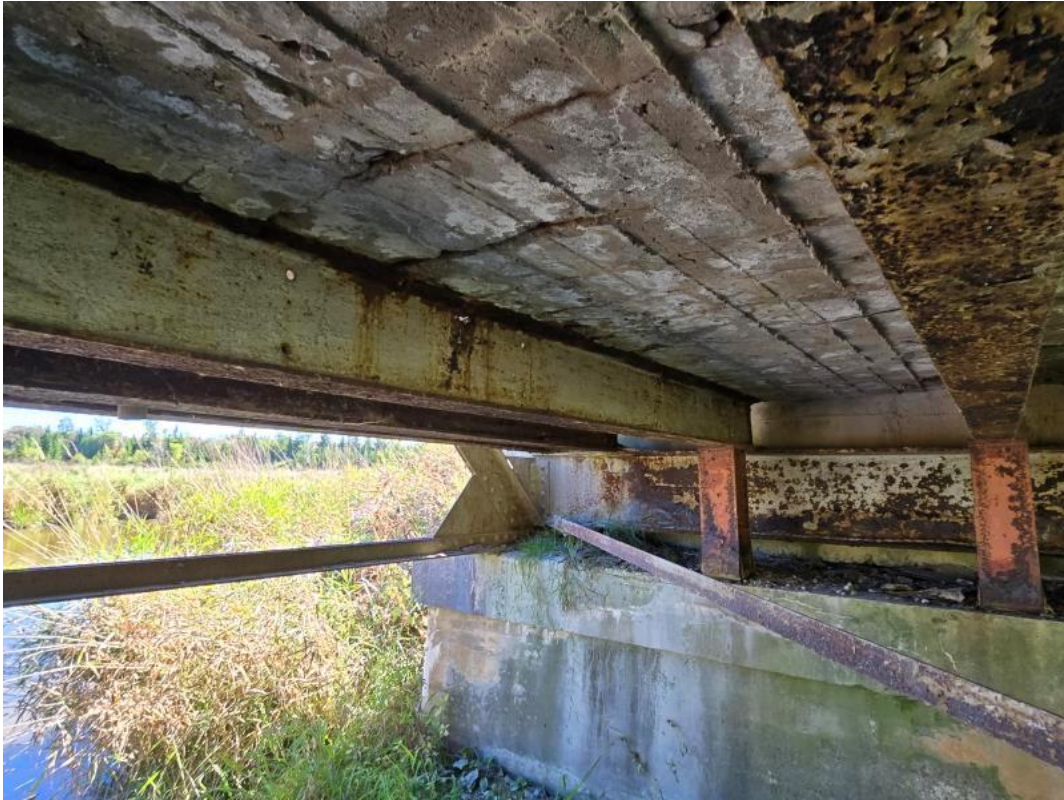
deck to the stringers along the outside edge. In the most southern bay, there appeared to be two stringers not providing any support for the deck because they are corroded through in places. The other four original girders are in poor condition and only the supplemental two stringers installed in 2002 are in fair to good condition.

South Bay Corroded Perforated Web
