**B. M. ROSS AND ASSOCIATES LIMITED**

**Re: Pearce Bridge, Structure E12**

# Ontario Structure Inspection Manual - Inspection Report:

Site Number: E12

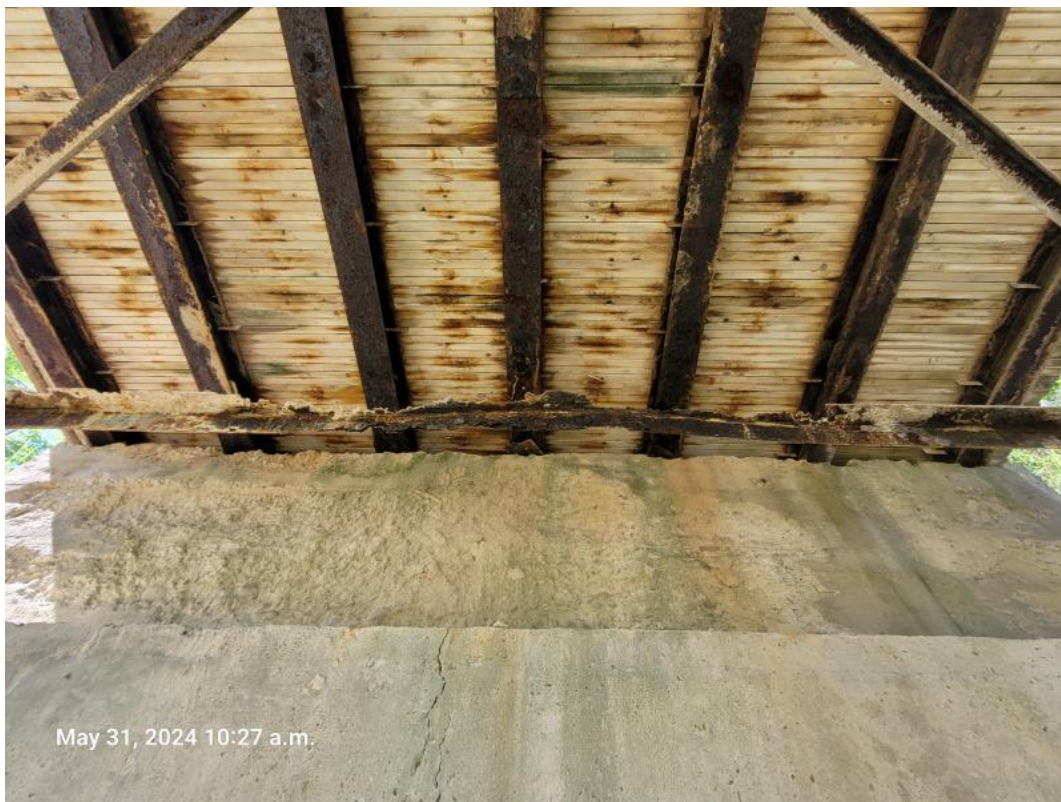
- Abutments have shifted in the past and there is a large crack in the south abutment. Efflorescence staining over 5% of the surface and should be removed and replaced.
- Top flange of most of the cross beams are corroding and some have lost 50% of their cross-sectional area.

4-South Abutment and South Stringer

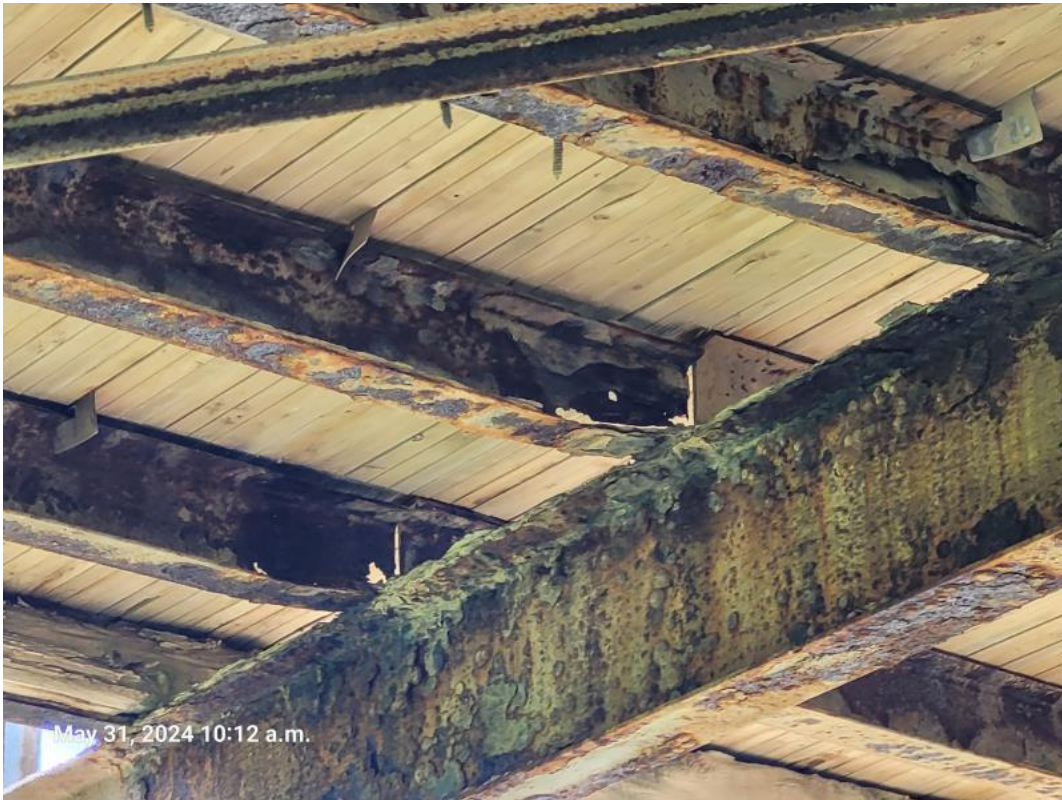
- About 25 to 30% of the floor beams (stringers) are deteriorated to the point that the beams are not providing any support for the bridge deck. Many of the other beams are still providing some support but are also in poor condition.
- The wooden deck is still in fair condition, but allows water to pass through the deck and on to the floor beams that are corroding and the deck will have to be removed and replaced to complete all the repairs.
- The bridge trusses on each side of the bridge are buckling. The buckle along the bottom tension chords is very obvious, and the top of the trusses are also bent. This condition reduces the ultimate capacity of the trusses and makes it more difficult to complete repairs to the structure.

Element Type:	I-type			Total Quantity:	123.5 m2	
Environment:	Moderate			Limited / Not Inspected:	<input type="checkbox"/>	
Protection System:	None			BCI - Element Condition Values:		
Condition Data:	Excellent	Good	Fair	Poor	TEV	CEV
			70% (86.45)	30% (37.05)	\$51,870	\$14,524
Comments:	Many floor beams are rusted through and providing no support for deck. From north to south: Bay 1 - 1 poor, 6 fair. Bay 2 - 4 poor, 3 fair. Bay 3 - 2 poor, 5 fair. Bay 4 - 2 poor, 5 fair. Bay 5 - 1 poor, 6 fair. Bay 6 - 3 poor, 4 fair. Bay 7 - fair.					
Performance Deficiencies:						
Recommended Work:	In lieu of replacing all the floor beams, replace the structure.				Recommended Timing:	< 1 year
Maintenance needs:						
Maintenance work:					Maintenance Priority:	
Element Data:						
Element Group:	Bracing			Length:		
Element Name:	Bracing			Width:		
Location:				Height:		
Material:	Steel			Count:	16	
Element Type:				Total Quantity:	16 Each

5-Bay 2 Stringers

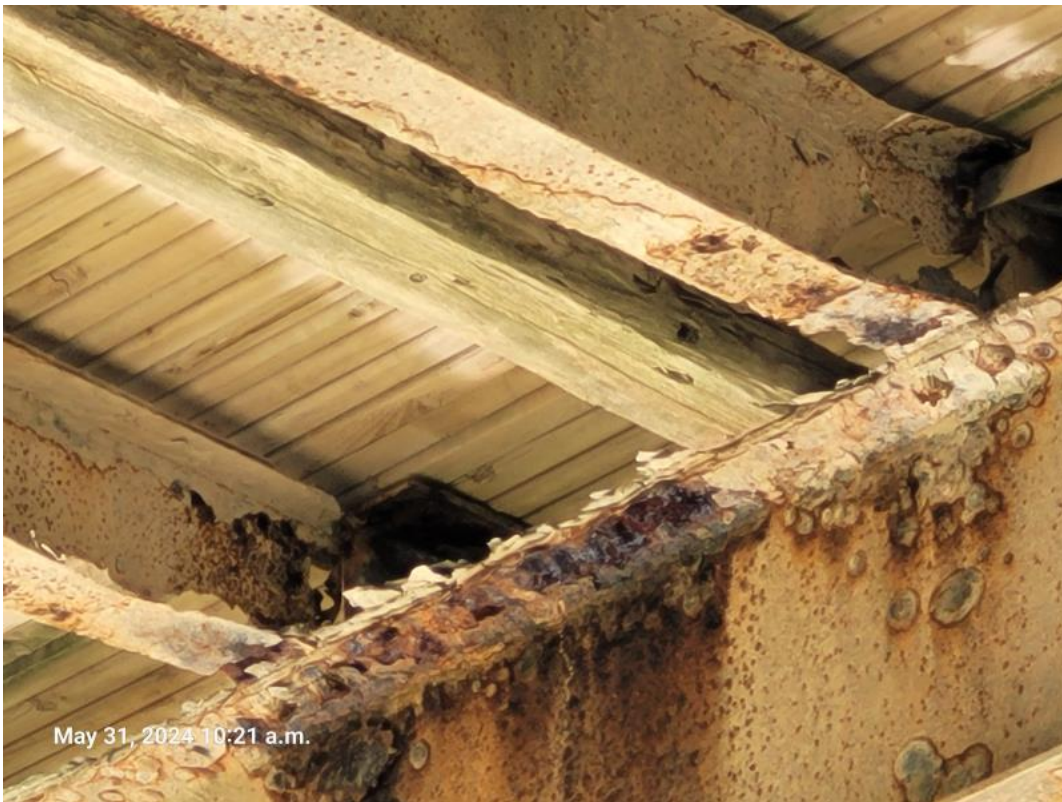
6-Bay 2 Crossbeam

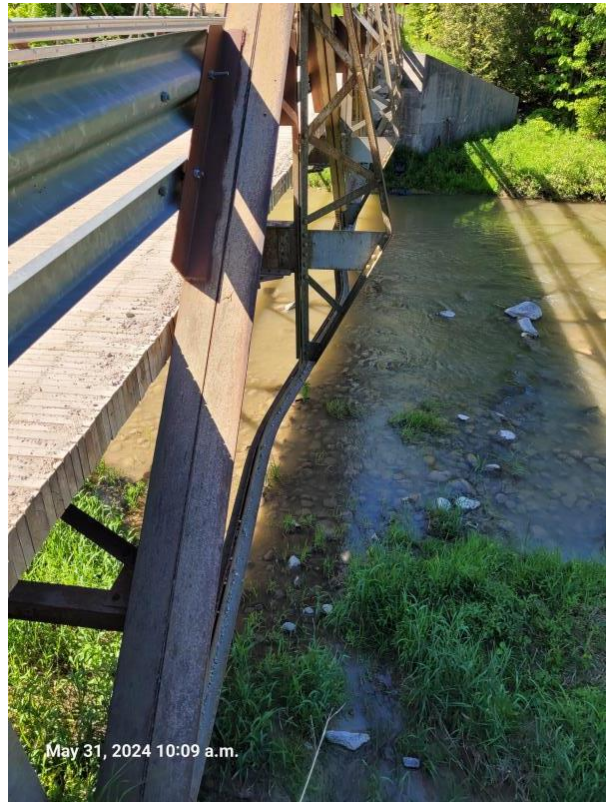
Location:				Height:	0.08	
Material:	Steel			Count:	2	
Element Type:				Total Quantity:	2 Each	
Environment:	Benign			Limited / Not Inspected:	<input type="checkbox"/>	
Protection System:	None			BCI - Element Condition Values:		
Condition Data:	Excellent	Good	Fair	Poor	TEV	CEV
				100% (2)	\$600	\$0
Comments:	At north end, both bottom chords buckled by abutment moving inwards. Monitor. Gravel on bottom chords and bearing seats.					
Performance Deficiencies:	None					
Recommended Work:	In lieu of repairs recommend replacing the structure.				Recommended Timing:	< 1 year
Maintenance needs:						
Maintenance work:	Remove gravel from bottom chords and bearing seats			Maintenance Priority:	Within 1 Yr.	
Element Data:						
Element Group:	Trusses/Arches			Length:		
Element Name:	Top Chords			Width:		
Location:				Height:		
Material:	Steel			Count:		
Element Type:	T-type			Total Quantity:		
Environment:	Benign			Limited / Not Inspected:	<input type="checkbox"/>

7-Bent West Bottom Chord

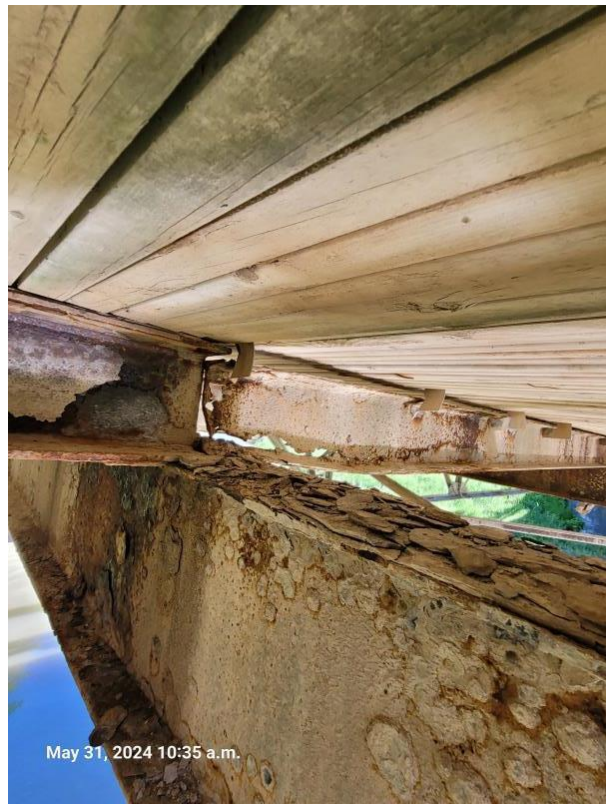
8-Crossbeam and Corroded Stringer

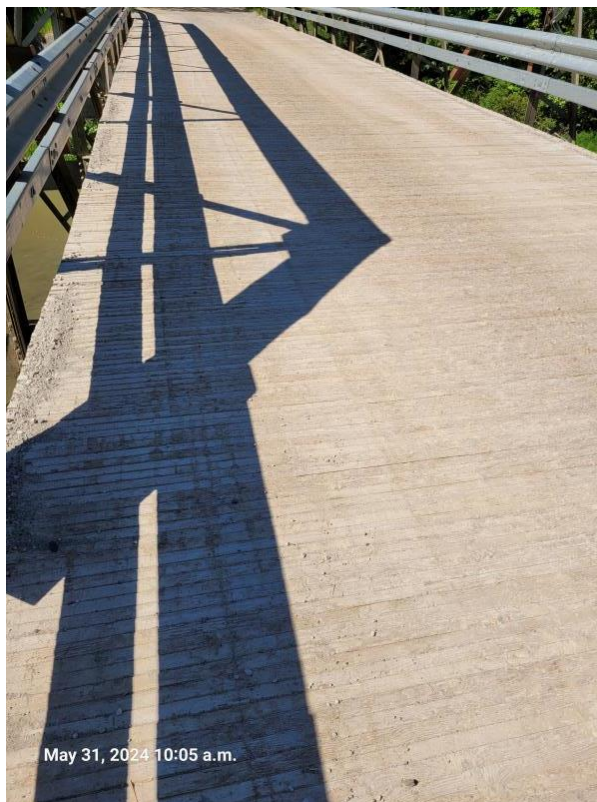
Element Data:						
Element Group:	Decks			Length:	29.3	
Element Name:	Deck Top - Thin Slab			Width:	4.9	
Location:				Height:	0.14	
Material:	Wood			Count:	1	
Element Type:	Laminated Wood Decking - transverse			Total Quantity:	143.6 m2	
Environment:	Severe			Limited / Not Inspected:	<input type="checkbox"/>	
Protection System:	Other			BCI - Element Condition Values:		
Condition Data:	Excellent	Good	Fair	Poor	TEV	CEV
			100% (143.6)		\$17,232	\$6,893
Comments:	Abrasion to wood wearing down the surface of deck. Wooden deck allows water through and onto the floor beams below that are corroding. Deck would have to be removed to complete other repairs.					
Performance Deficiencies:	None					
Recommended Work:	Replace structure.				Recommended Timing:	< 1 year
Maintenance needs:						
Maintenance work:					Maintenance Priority:	
Element Data:						
Element Group:	Trusses/Arches			Length:	27.1	
Element Name:	Bottom Chords			Width:	0.16

9-Deck Top

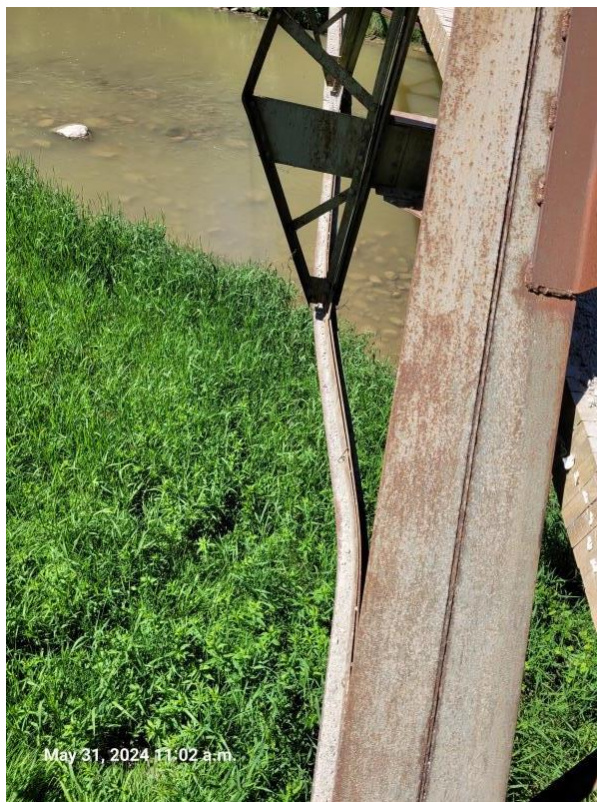
Bent East Bottom Chord

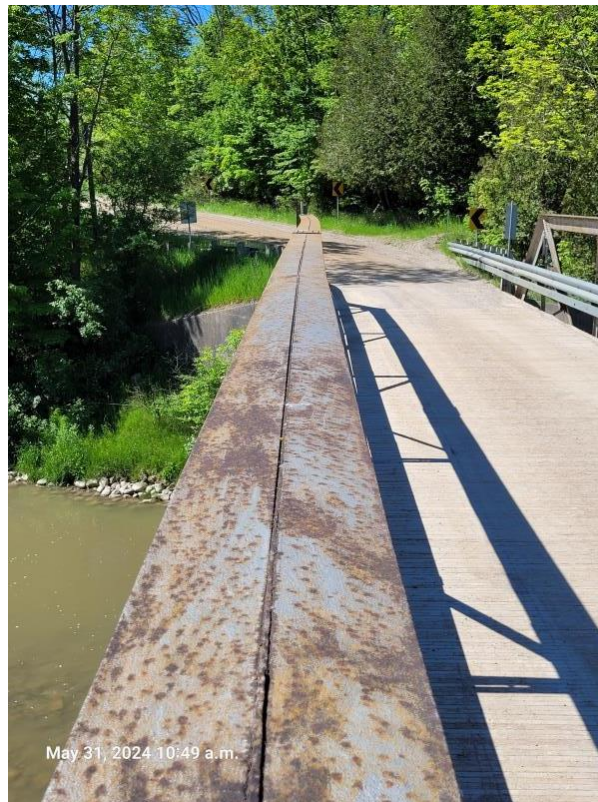
Protection System:	None			BCI - Element Condition Values:		
Condition Data:	Excellent	Good	Fair	Poor	TEV	CEV
			80% ()	20% ()		\$0
Comments:	Element includes remaining truss members (top chord, vertical and diagonal members). Curve in top chord of each truss. Coating system is not protecting steel and surface rust is present throughout trusses.					
Performance Deficiencies:						
Recommended Work:	Replace structure.				Recommended Timing:	< 1 year
Maintenance needs:						
Maintenance work:					Maintenance Priority:

Top Chord-East Truss
