## Tara Pool Project Update

Prepared for: Carly Steinhoff, *Manager of Facilities, Parks and Recreation for Arran-Elderslie*

Prepared by: Tara Rotary Club

November 18, 2022

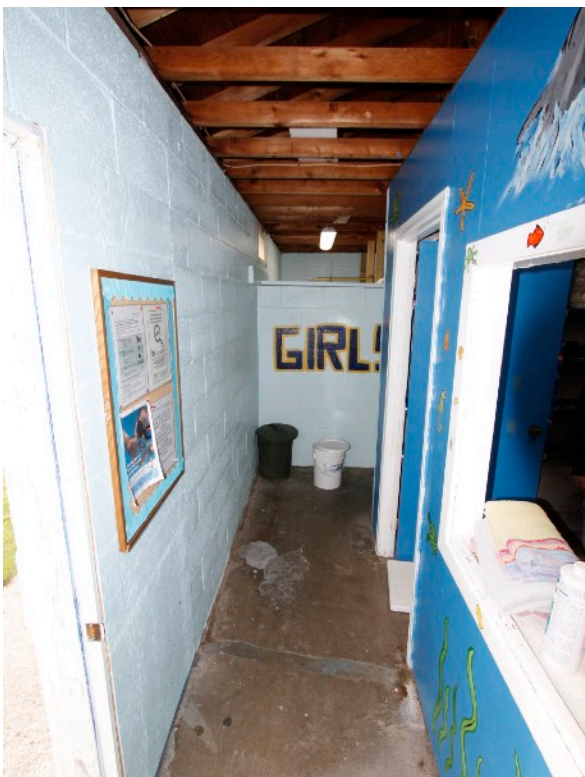
Main entrance to change rooms - Before

The condition of the floor is in poor shape from the front entrance to the change rooms and exits from the lifeguard desk, through the mechanical room to the Lifeguard exit. This makes the floor very dirty, difficult to clean and a source of mold and dirt to users, the pool deck and pool itself. Item#1 of phase 1 is to thoroughly clean the entire floor, via chemical or mechanical abrasion, add radius fillets to all wall to floor joints and paint/seal the floor with an epoxy paint. This will allow the floor to be cleaned much easier and prevent mold and dirt buildup in the cracks and wall seams.

Floor cleaned, grinded and all holes and cracks filled. Walls also ground up approximately 4" from the floor to wall seam and the floor seams were filled.

After finishing with epoxy coatings, decorative flakes, four Polyaspartic top coats for chemical resistance and “shark skin” anti-slip additive.

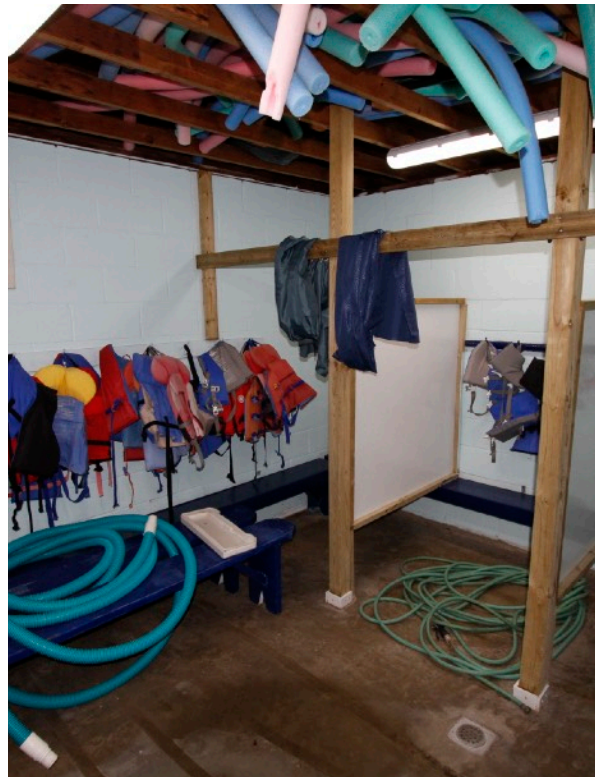
General change room floors - Before

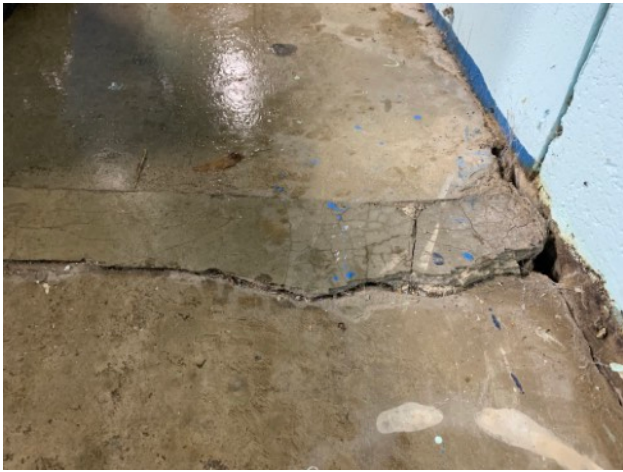
Large crack in main entrance

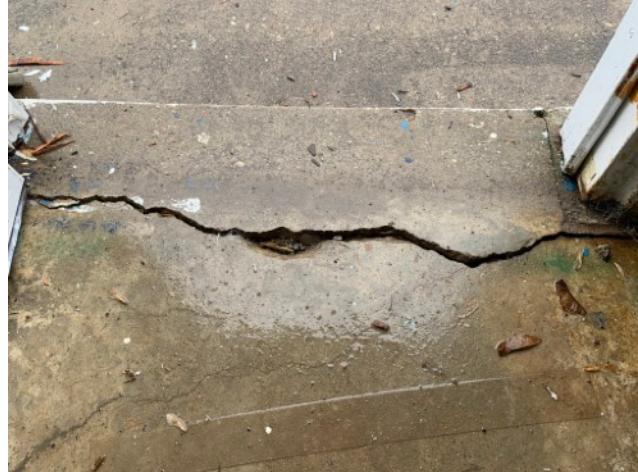
Crack in doorway

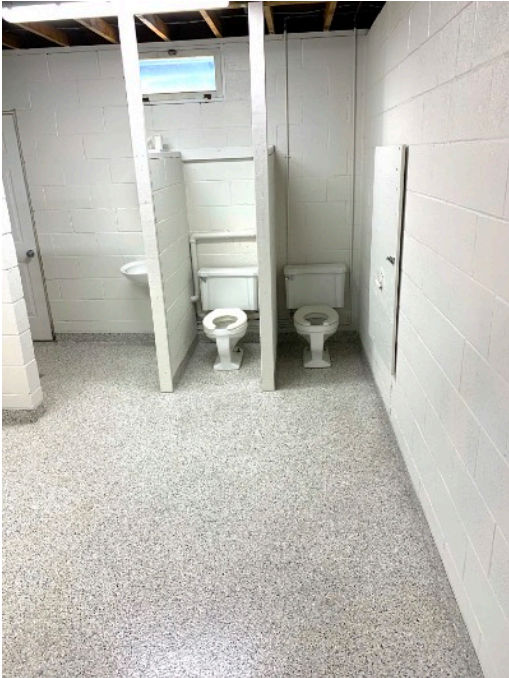
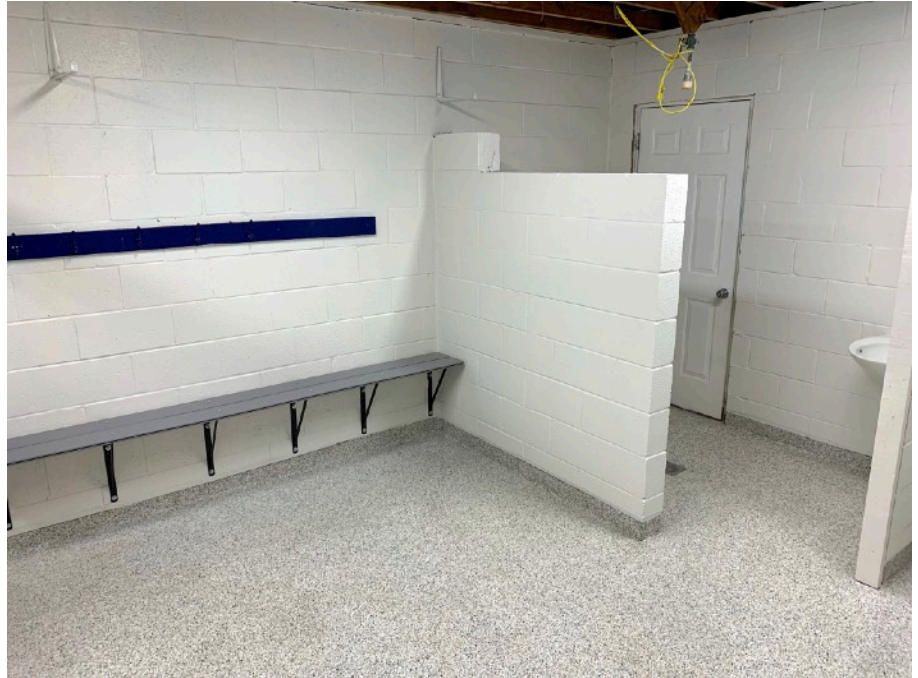
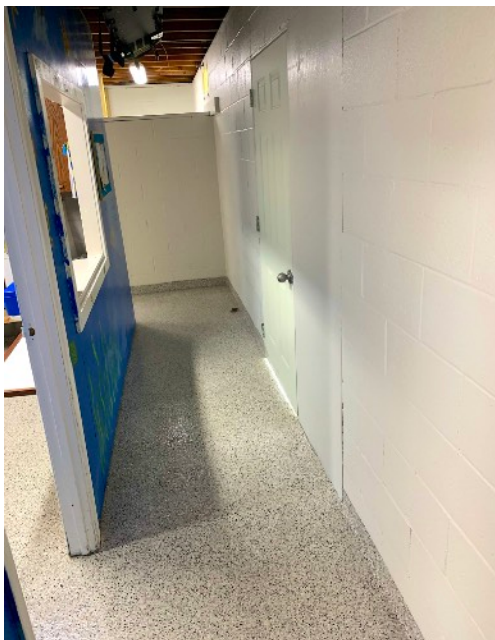
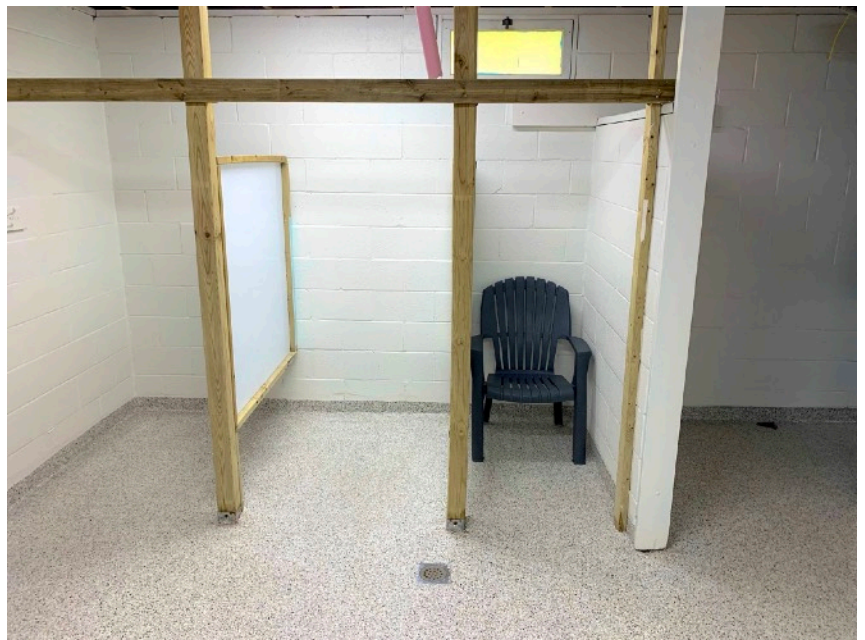
Floors finished, cracks and holes filled.  
All walls shown re-painted and cracks filled. (Scope addition)

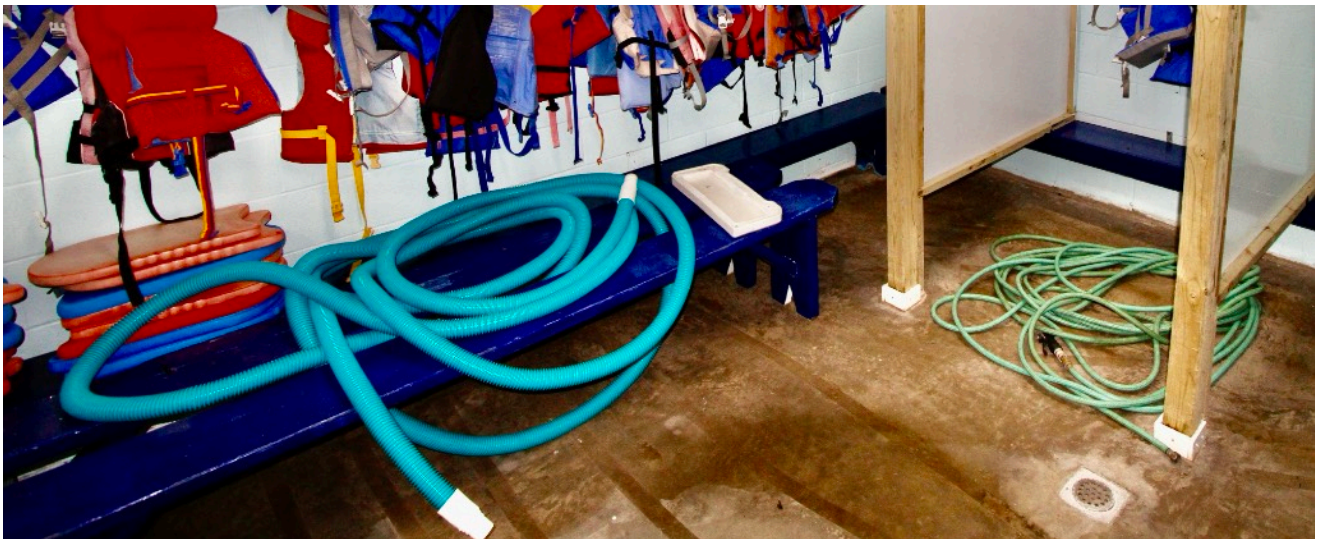
The current benches have a rough paint finish and have legs that sit on the floor. This makes it very difficult to not only clean the benches, but get around the legs on the floor. Item #2 of Phase 1 is to replace all of the benches in the Boys and Girls change rooms with wall mounted, easy to clean benches.

Benches on floor

**Finished benches in both change rooms**

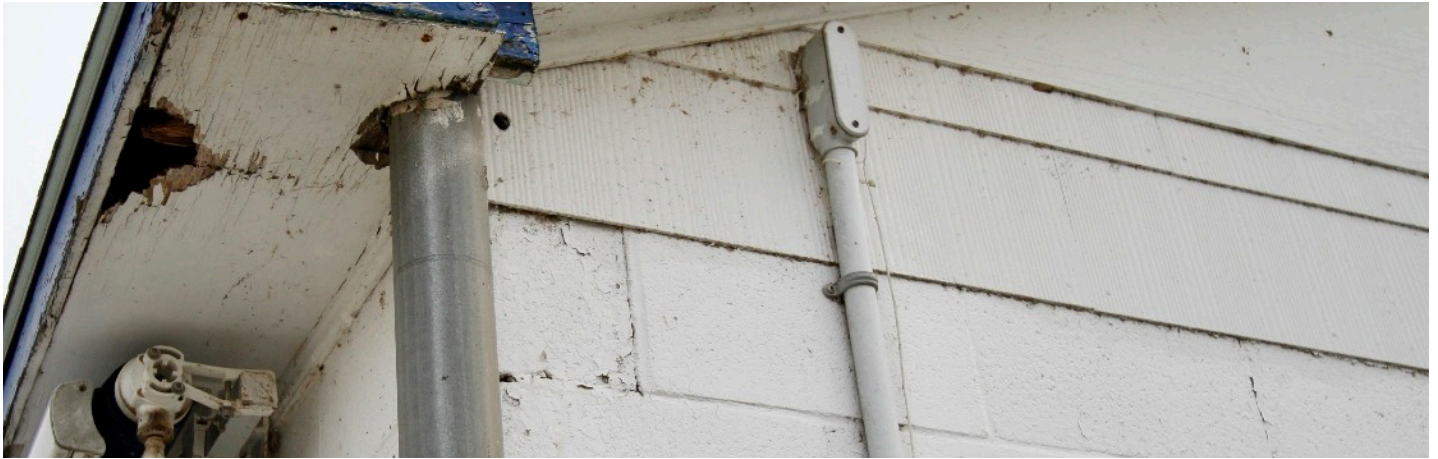
Each change room only has one passive vent in each eave as shown above. This is not enough ventilation for a damp pool change room and will contribute to mold generation. Item #3 of phase 1 is to slightly enlarge each of the two vents, install two ventilation exhaust fans with wiring and switches, install vents in soffits to allow fresh air flow and repair existing holes in soffits/facia. The fans are sized to exceed current locker room air exchange Building Code requirements.

Existing Soffits - Rot and no vents.

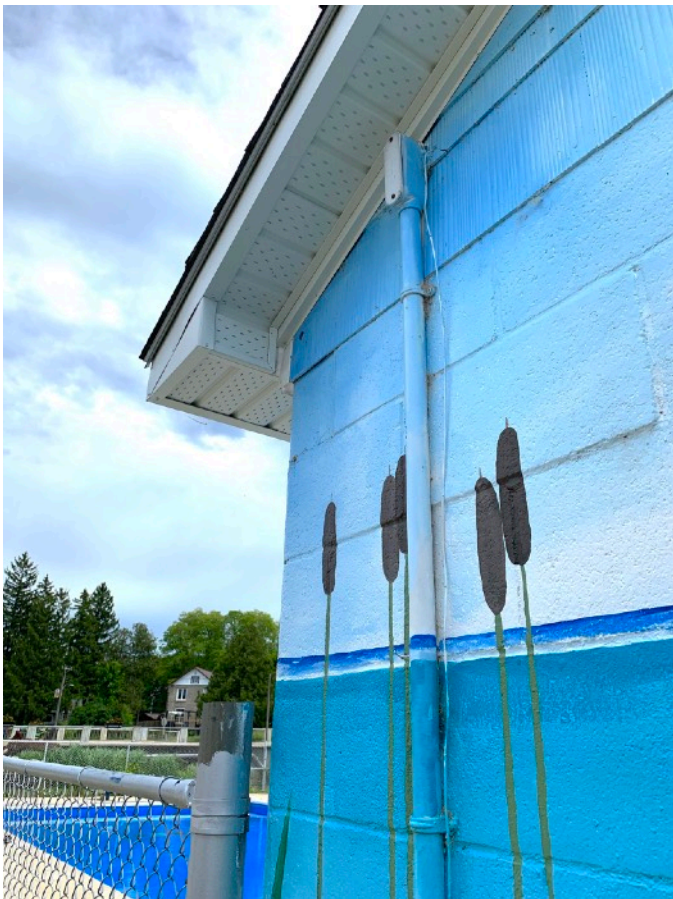
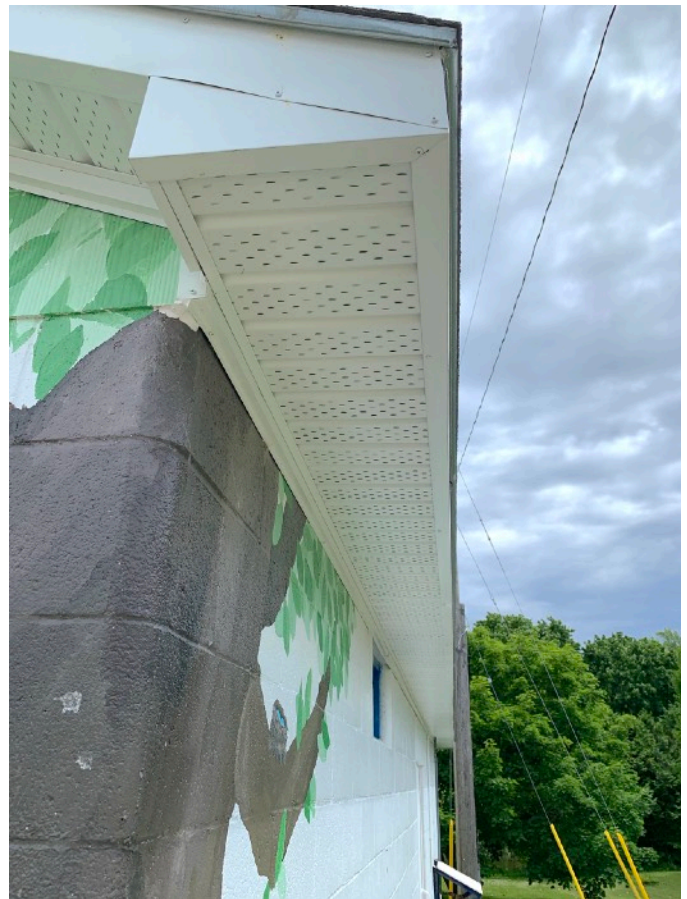
New vented soffits and fascia installed

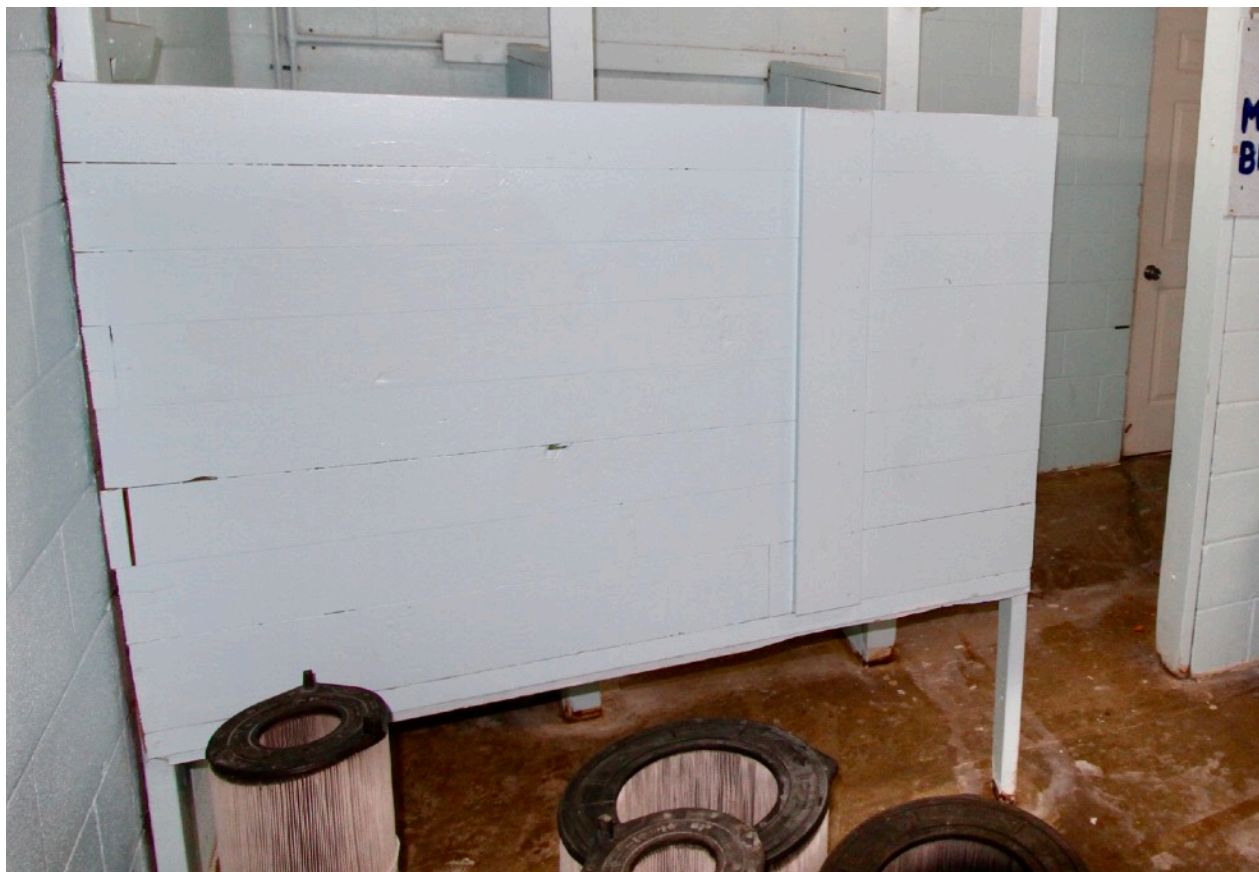
The supports for the boys change room toilet dividers are rotten at the floor and they impede daily floor cleaning. Item #4 of phase 1 is to cut and re-position the divider poles and replace the divider material to make it easier to clean and get poles off the floor.

**Boys toilet area divider rotten at floor and blocks cleaning**

Divider removed, holes in floor and wall filled and vertical rotted divider wall supports replaced.

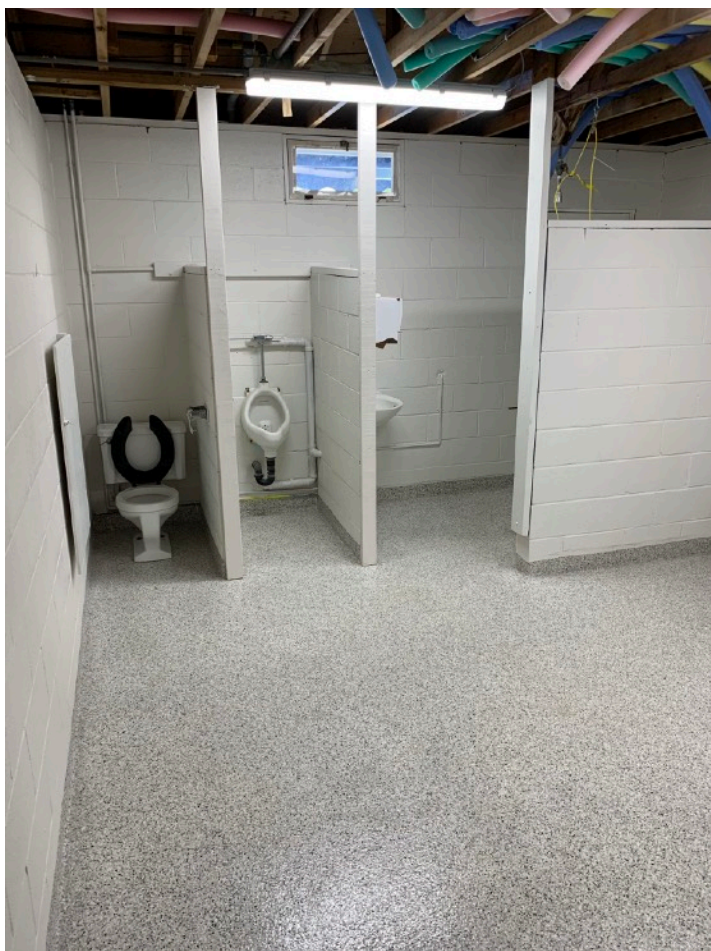
New toilet area.

Dividers not required and impair movement from change room to pool area.

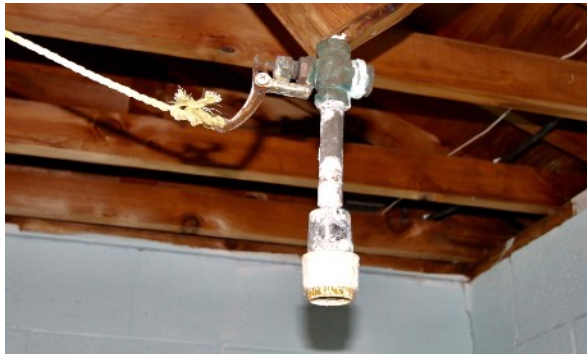
Rope actuated shower in each change room

Item #5 of Phase 1 is to replace the shower head and valve in each change room to make them more useable and less prone to failure.

Due to challenge obtaining suitable water controllers, this replacement was delayed. Valves cleaned and leaking toilet isolators replaced. To be replaced in 2023.

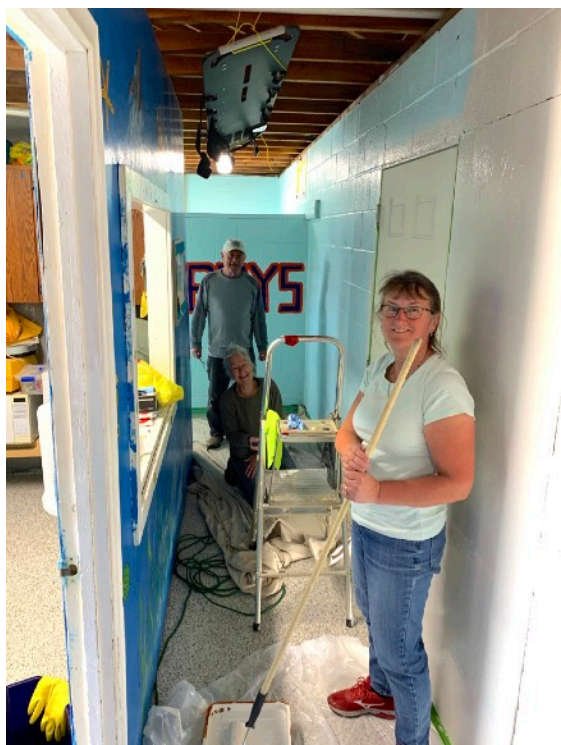
Cleaning and painting in progress

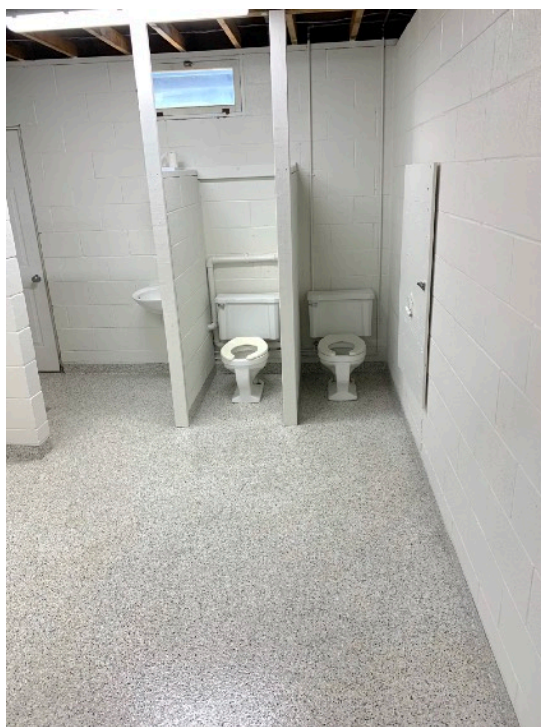
Finished walls

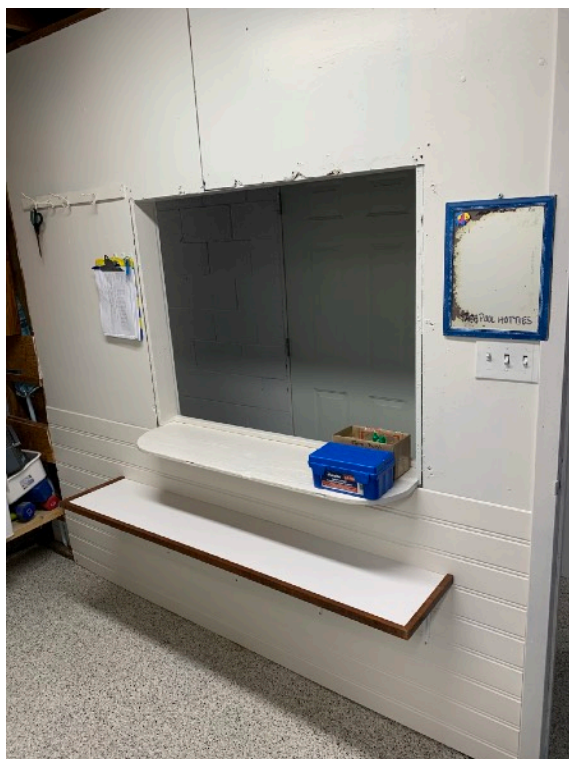
New shelf and backboard

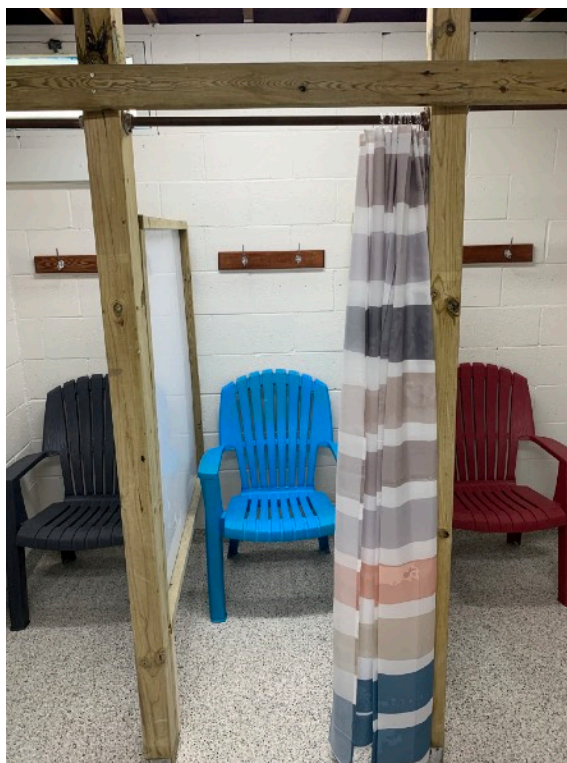
New coat hangers and chairs instead of short benches
