## Summary Report:

Structure Name: Ross St. Bridge

Road Name: Ross Street

Inspection Date: 2020-09-18

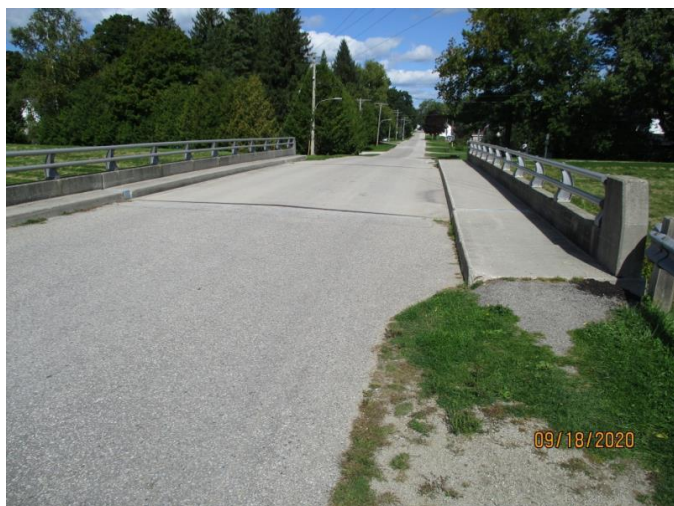
Looking North

Overall Comments: Box beam of girders in fair condition. Recommend patch repairing abutment walls, barriers and deck. Waterproof and pave deck.
